# Natural Resource Protection Act (NRPA) Identification Guide for Rivers, Streams, and Brooks

Danielson, T. J. 2018. *Natural Resource Protection Act (NRPA) Streams, Rivers, and Brooks*. Maine Department of Environmental Protection, Augusta, ME.

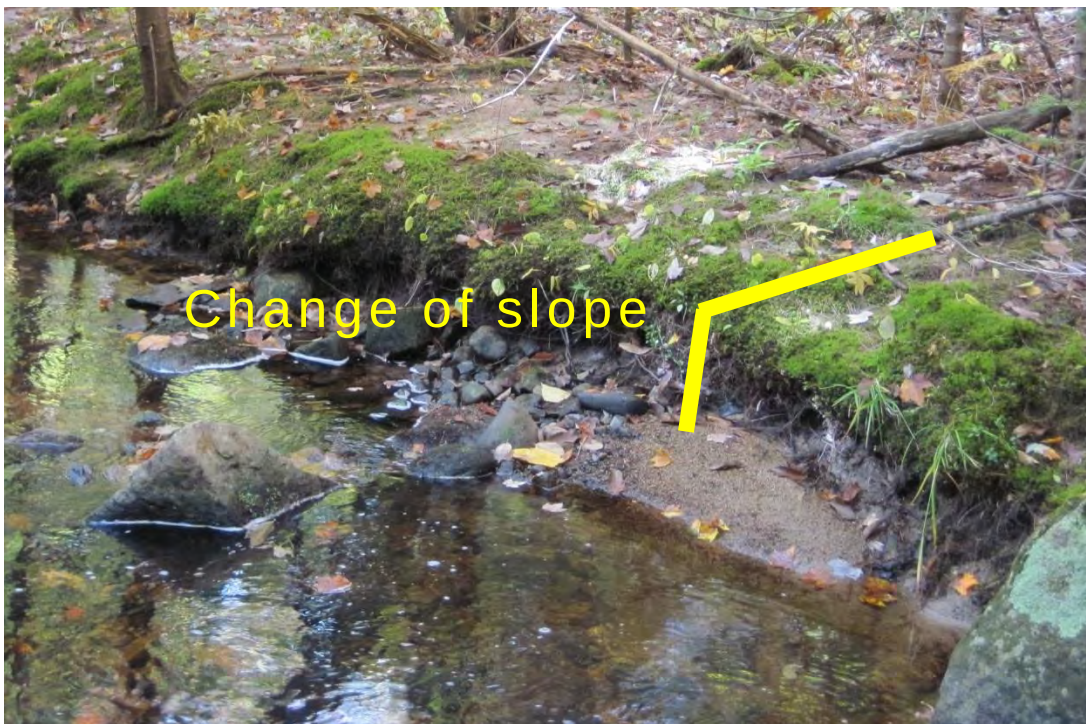
Figure 2. Stream channel showing a distinct change of slope where the stream bank transitions to the floodplain

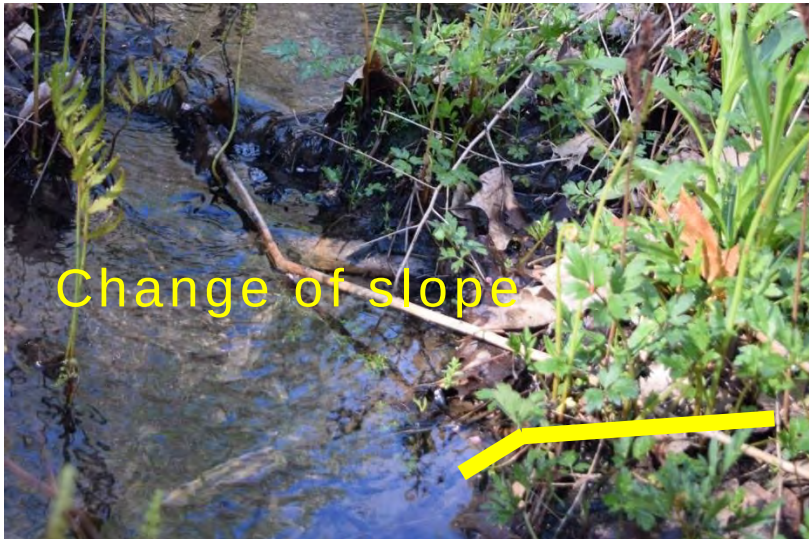
Figure 3. Small stream channel showing a less distinct change of slope where the stream bank transitions to the wetland

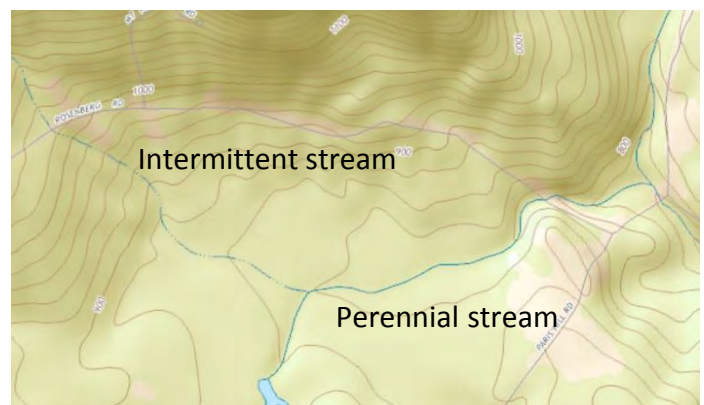
Figure 4. Solid and broken lines on 7.5-minute USGS topographic map representing perennial and intermittent streams, respectively

broken line (Figure 4). Solid lines represent perennial streams. Broken lines represent intermittent streams that may dry up. It is worth noting that many headwater streams do not appear on topographic maps, but the location of their channels may appear as U-shapes in elevation contours, which point uphill (Figure 4 – Intermittent Channel). Rarely, some channels that are mapped as streams do not meet two or more other criteria and therefore are not considered streams or brooks under the NRPA.

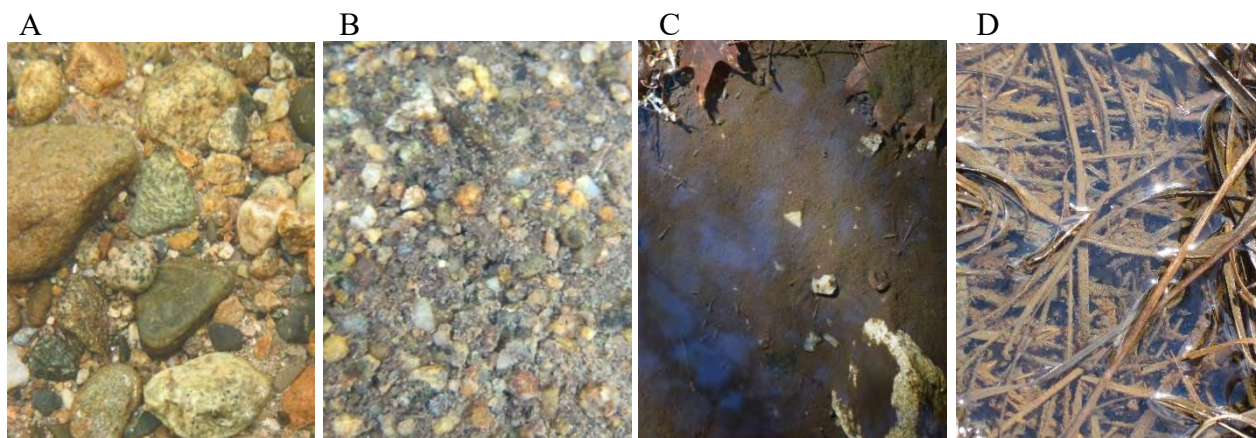
Figure 5. Examples of mineral substrate including (A) cobble and gravel, (B) coarse sand, and (C) mud, composed of sand and silt with some organic matter. Example of an organic substrate composed of a thick layer of decomposing plants (D).

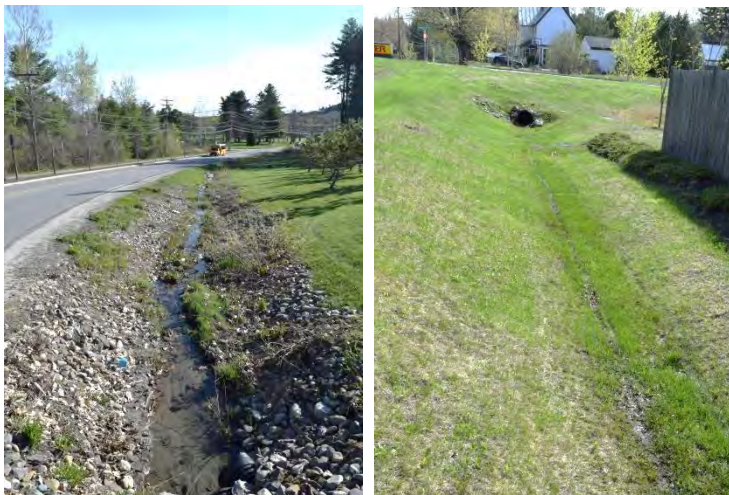
Figure 5. Examples of a drainage ditch and a grassy swale

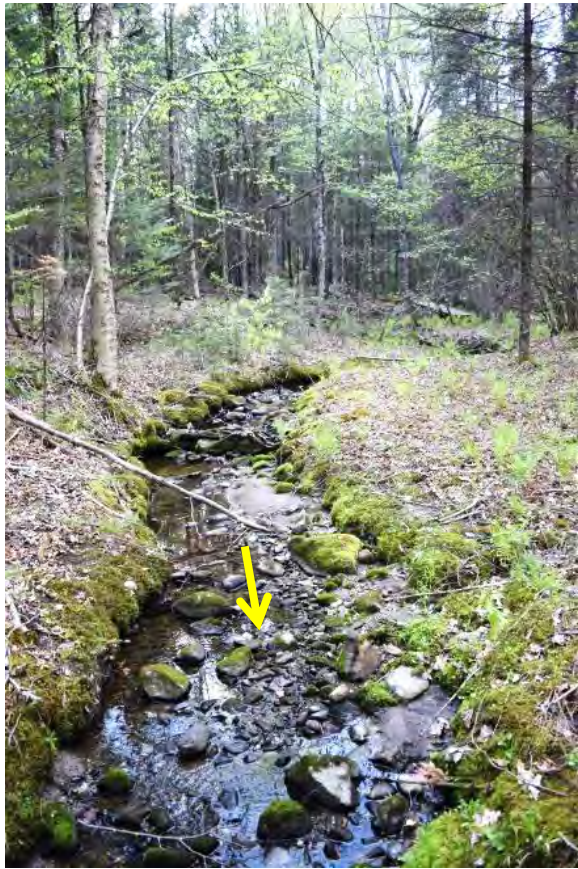
## Case Study 1 – Perennial stream

| Criteria | Evidence | |
|---|---|---|
| Channel | ✓ | Clearly defined channel and banks (2-3 feet wide) |
| D. Aquatic life | ✓ | Many different kinds of aquatic macroinvertebrates and a two-lined salamander were observed |

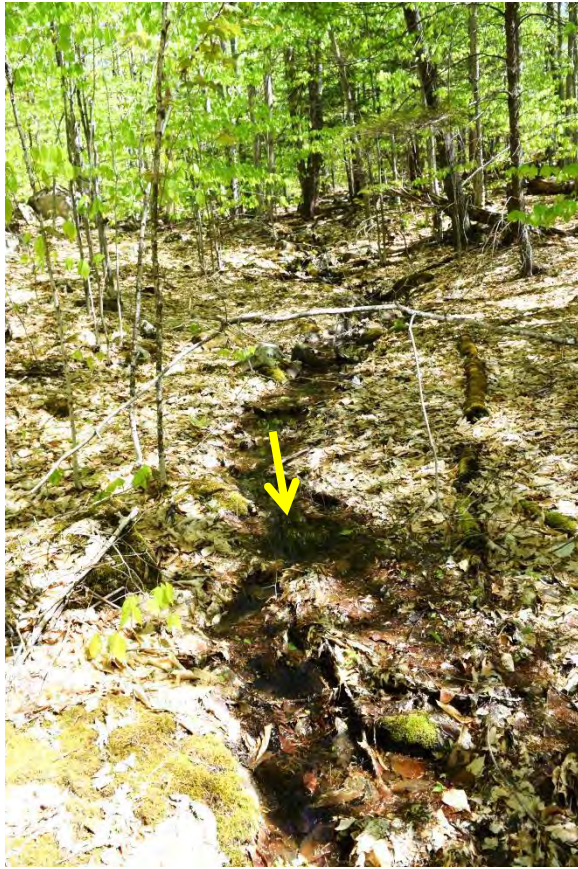
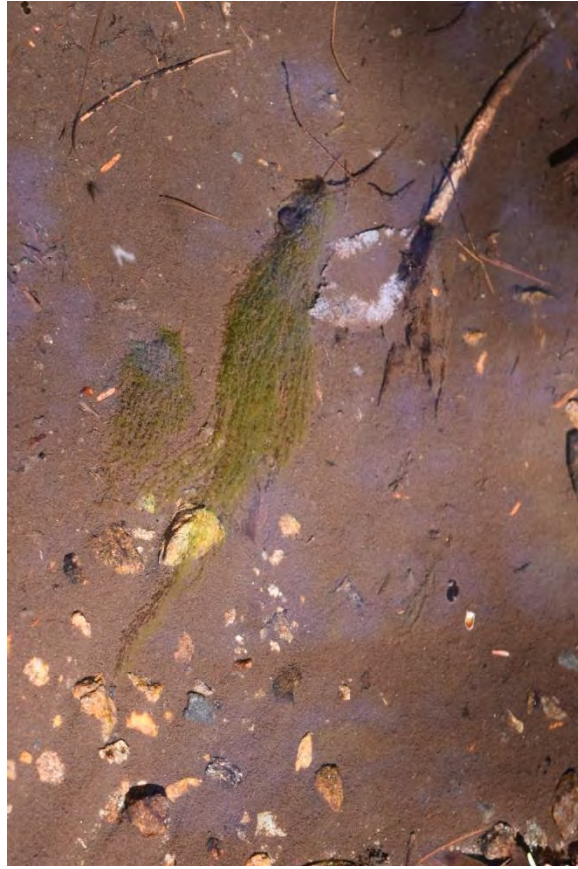
## Case Study 2 – Intermittent drainage #1

| Criteria | Evidence | |
|---|---|---|
| Channel | ✓ | Narrow channel with defined banks (3-8" wide, <1" deep in most places) (A) |
| D. Aquatic life | ✓ | Several different kinds of aquatic macroinvertebrates and a two-lined salamander were observed |
| Conclusion | ✓ | It has a defined channel and meets 2 of the 5 other criteria. It is a NRPA stream. |

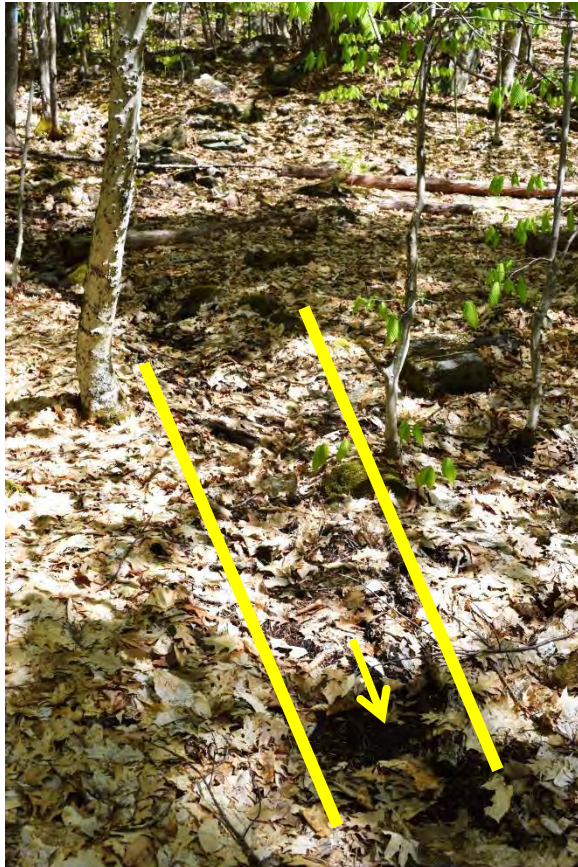
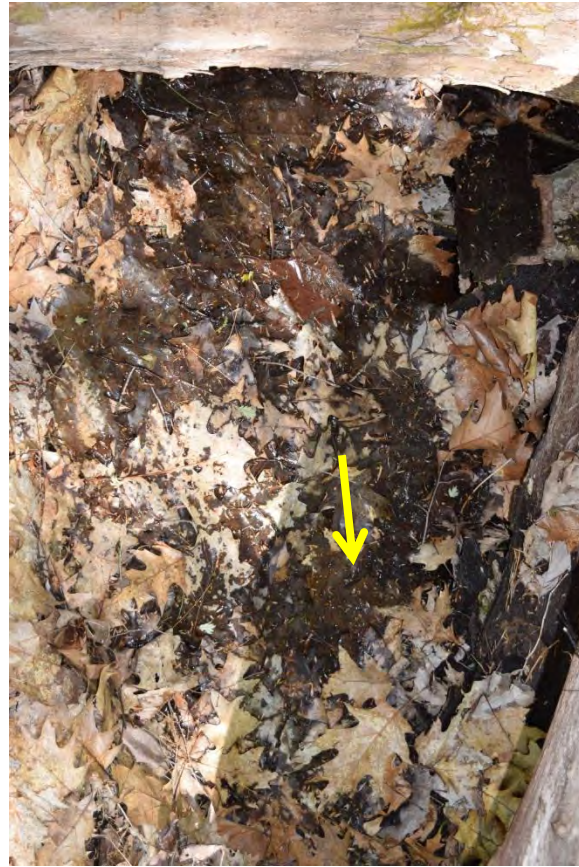
### Case Study 3 – Intermittent drainage #2

| Criteria | Evidence |
|---|---|
| Channel | × Water flowing through leaves, but there is no defined channel (yellow lines added to show area with flowing water) |
| D. Aquatic life | × None found in a 15-minute search |

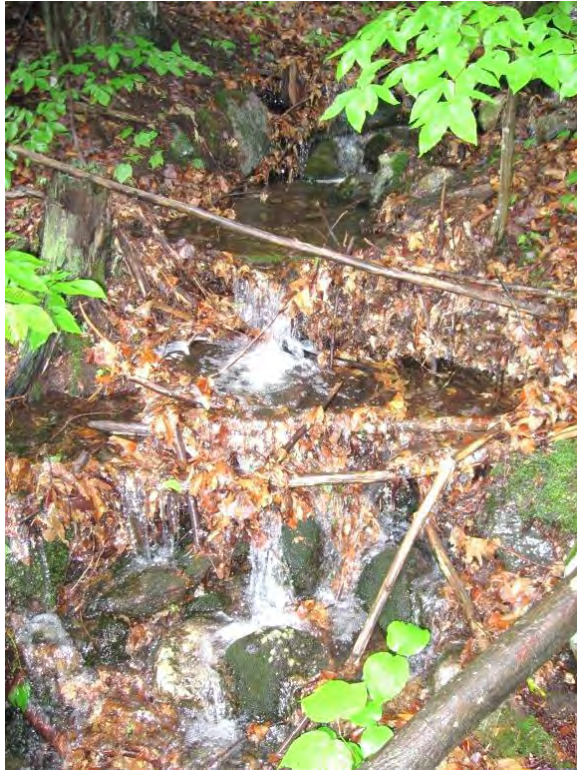
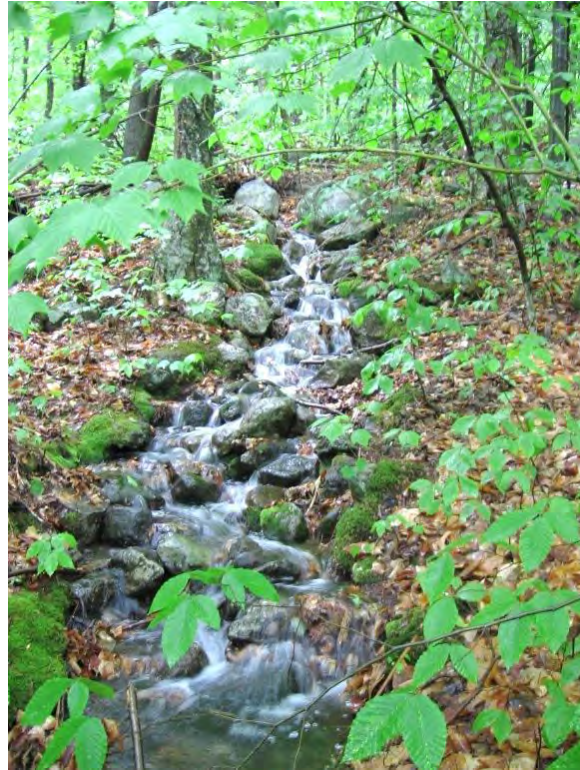
## Case Study 4 – Intermittent drainage #3 (high gradient)

| Criteria | Evidence |
|---|---|
| Channel | ✓ Upstream segment (A) is on a hill side and has a step-pool channel that is common to steep streams. The downstream segment has a standard channel with rock substrate (B). |
| A. Mineral channel bed | ✓ There is exposed mineral substrate caused by flowing water |

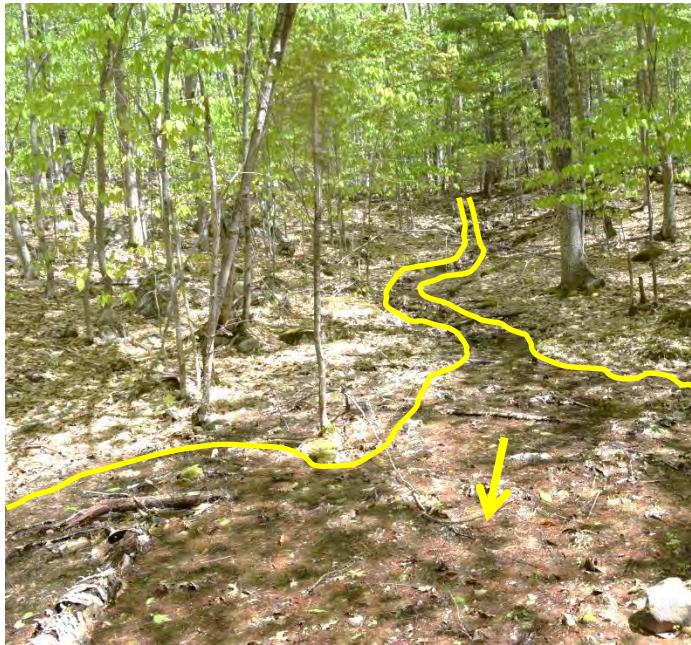
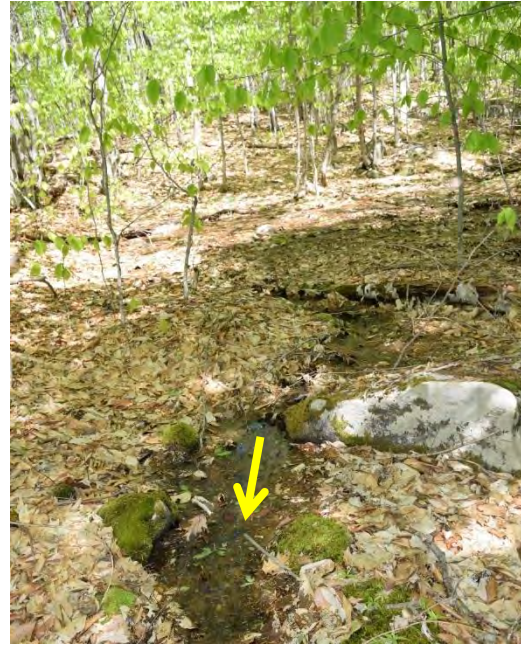
## Case Study 6 – Stream that changes to a wetland and then back (2 pages)

| Criteria | Evidence |
|---|---|
| D. Aquatic life | ✓ Several different kinds of aquatic macroinvertebrates, such as mayflies, stoneflies, caddisflies, and blackflies. A two-lined salamander was observed. |
| Conclusion | ✓ It has a defined channel and meets 2 of the 5 other criteria. This segment is a NRPA stream. |

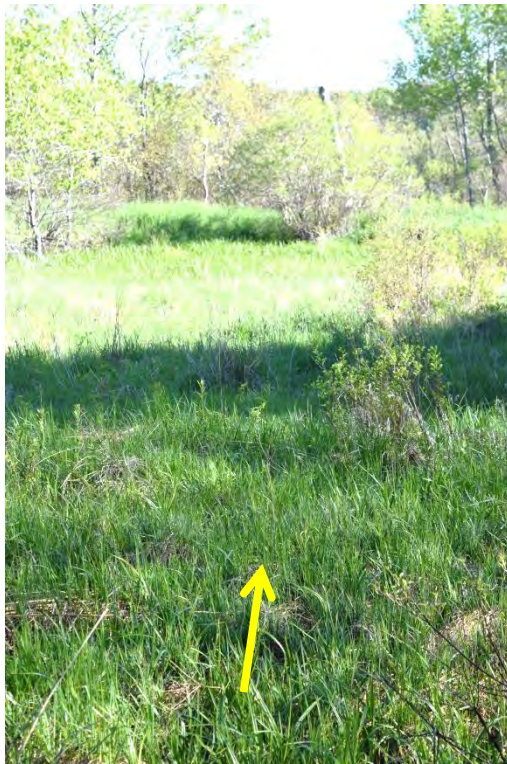
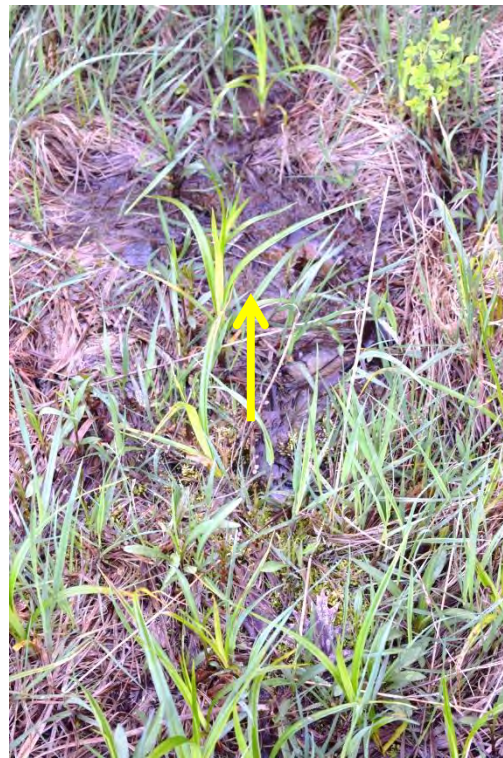
## Case Study 7 – A marsh without a channel

| Criteria | Evidence | |
|---|---|---|
| Channel | × | Water flowing through plants when water levels are high, but no channel |

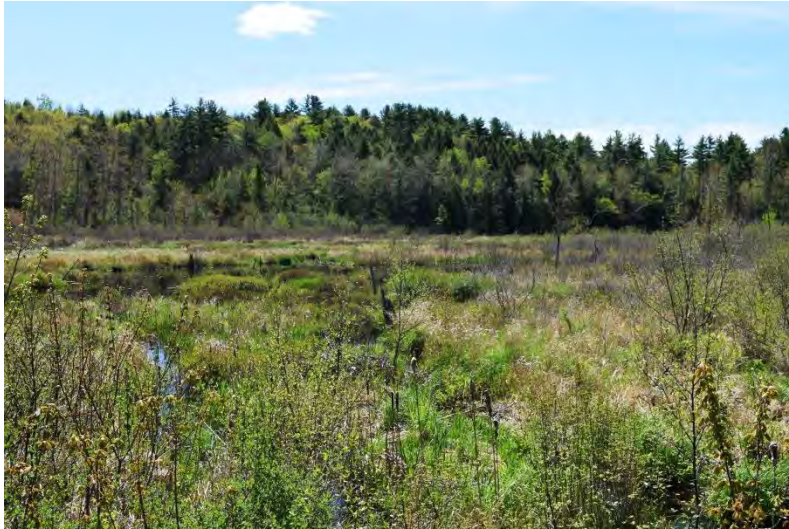
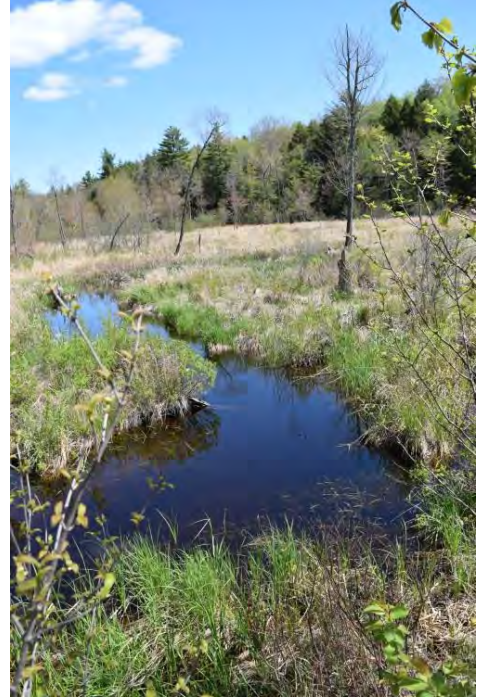
## Case Study 8 – A marsh with a channel

| Criteria | Evidence |
|---|---|
| Channel | ✓ Although there appears to be no channel from View 1, there is clearly a channel with defined banks if one explores a little (View 2). |
| D. Aquatic life | ✓ Many different kinds of aquatic macroinvertebrates, such as mayflies, stoneflies, and caddisflies. Fish were observed. |
| Conclusion | ✓ It has a defined channel and meets all other criteria. It is a NRPA stream. |

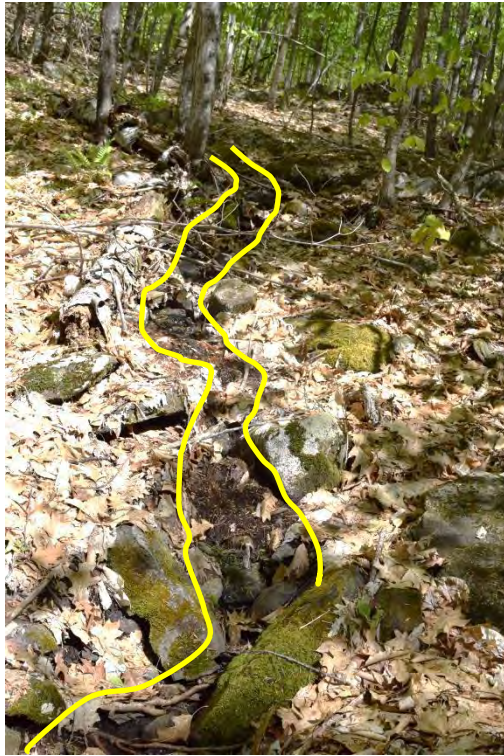
## Case Study 9 – Dry channel

| Criteria | Evidence |
|---|---|
| Channel | ✓ Channel with defined banks (yellow lines added to show banks) |
| D. Aquatic life | ✓ Caddisfly cases were found on a rock and a few macroinvertebrates were found in the last remaining pool |

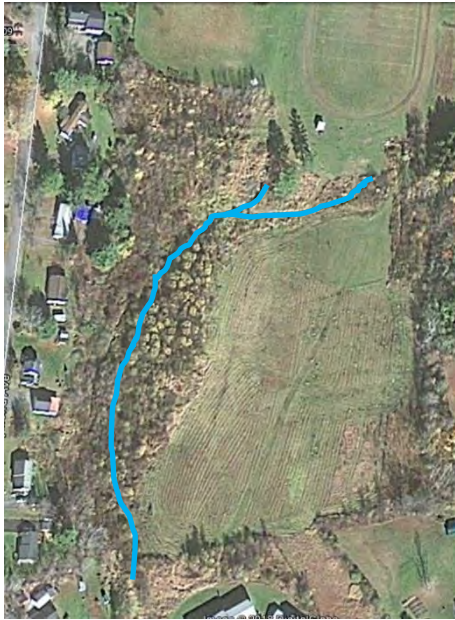
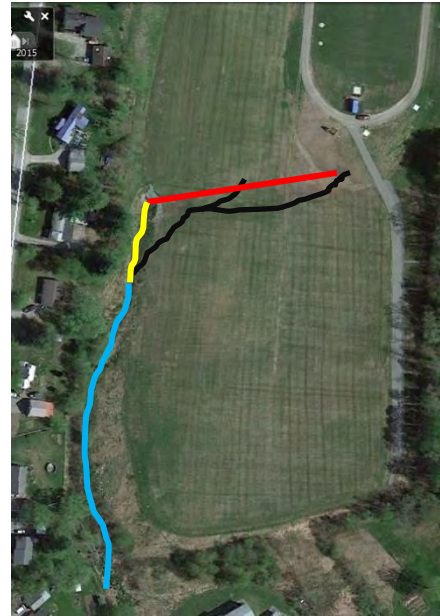
## Case Study 10 – Relocated stream that originates from a culvert

A stream (A & B – blue lines) was modified to accommodate the construction of an athletic field. The stream originated from 2 pipes before construction because of the original athletic fields. A section of stream was buried (B – black lines). A pipe was installed to convey water (B – red line). Part of the channel was relocated to minimize impacts of the project (B – yellow line).

| Criteria | Evidence |
|---|---|
| D. Aquatic life | ✓ Several kinds of macroinvertebrates observed |

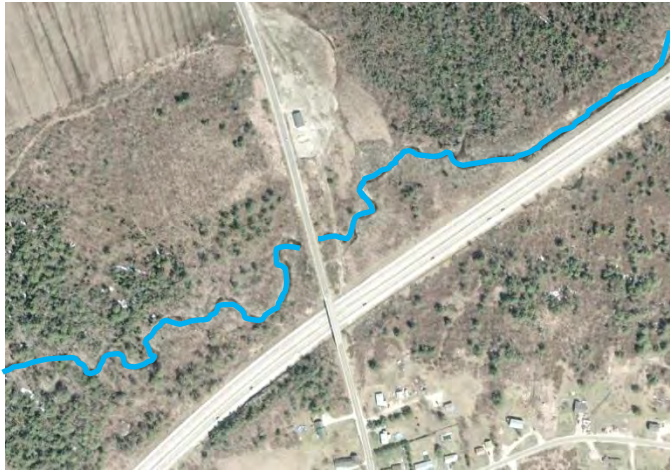
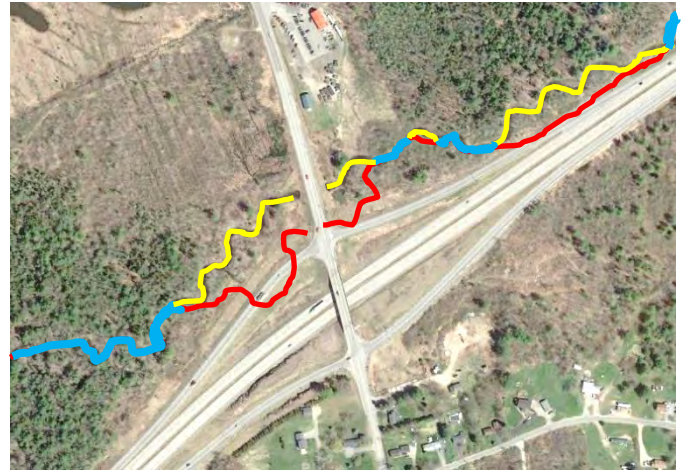
Parts of a stream were relocated to accommodate construction of highway ramps and to move a portion of the stream away from the highway. Blue lines show the stream channel prior to construction (A and B). Red lines show buried stream segments (B). Yellow lines show relocated stream segments (B).

| Criteria | Evidence |
|---|---|
| Conclusion | ✓ The entire stream, including the relocated stream segments (B – yellow lines), is a NRPA stream. It has a channel and meets all other criteria. The stream segment that ran alongside the road (A) also was a NRPA stream. |

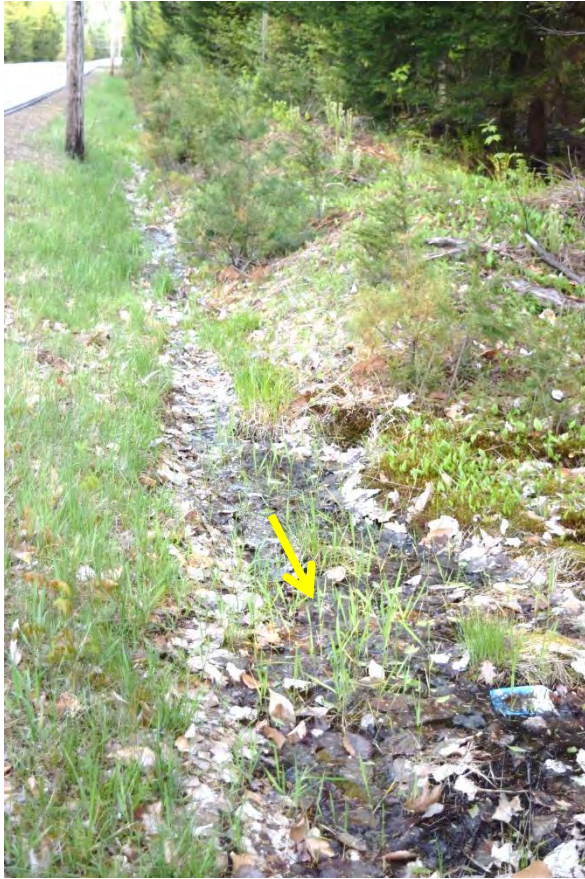
## Case Study 12 – Roadside Drainage #1

| Criteria | | Evidence |
|---|---|---|
| Channel | ✓ | Within the drainage feature, there is a narrow, meandering channel. |

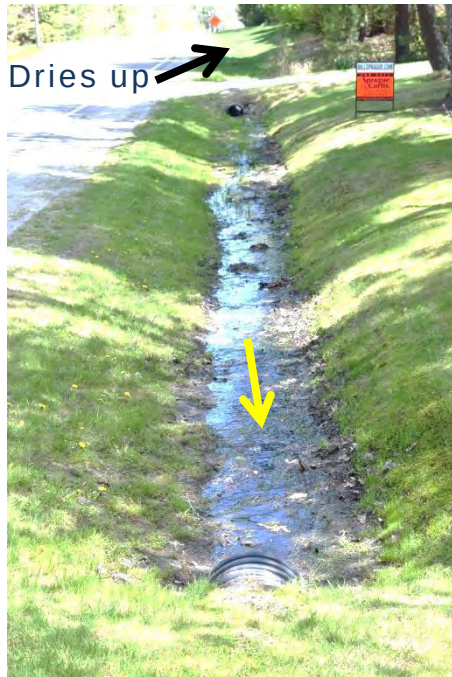
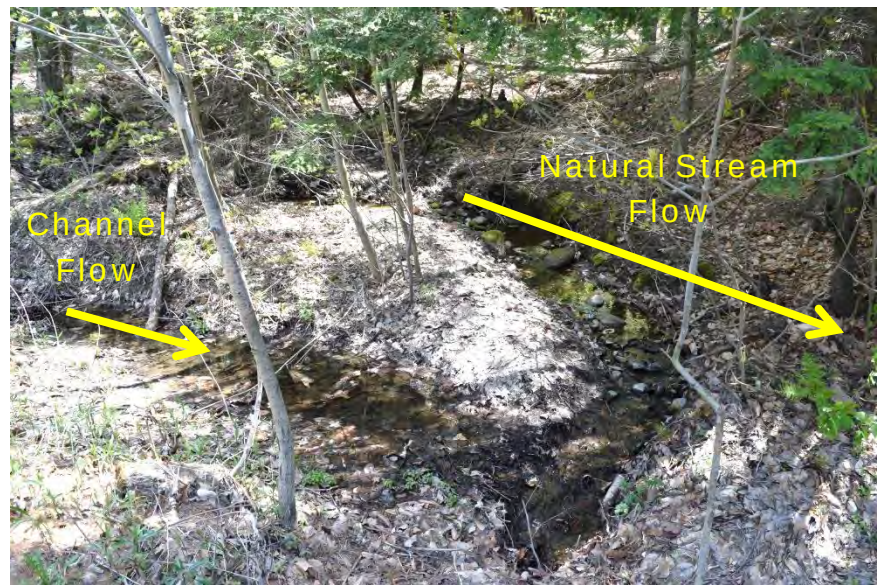
## Case Study 13 – Roadside Drainage #2

| Criteria | Evidence |
|---|---|
| Channel | ✓ Channel alongside of a road (A). |

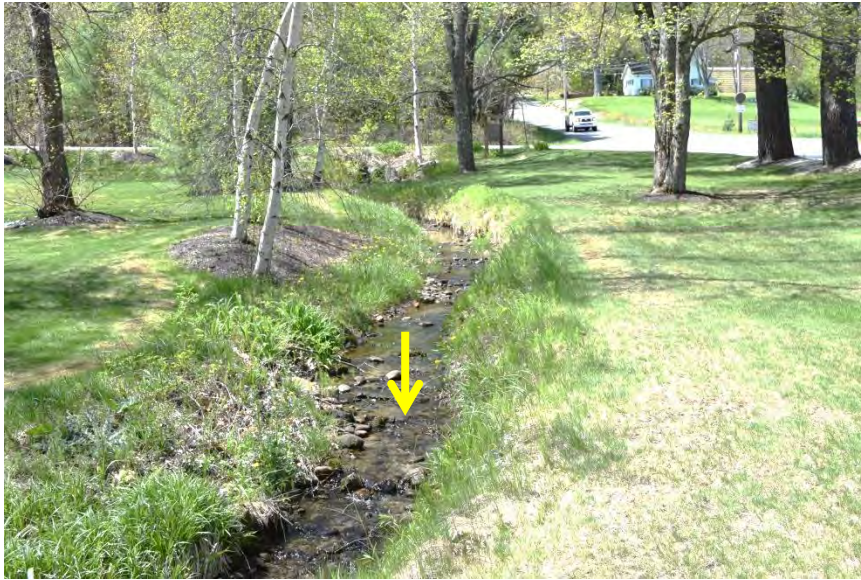
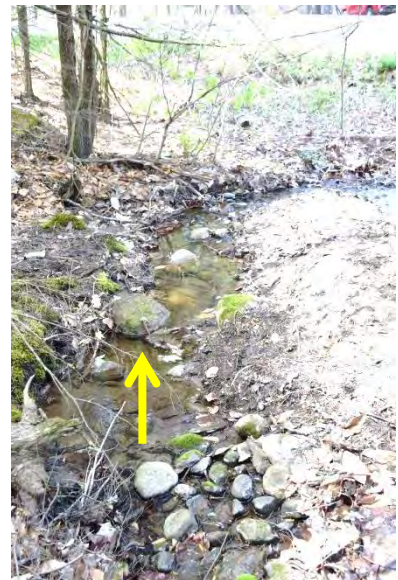
## Case Study 14 – Roadside Drainage #3

| Criteria | Evidence |
|---|---|
| Channel | ✓ Channel with defined banks (A, looking upstream). |

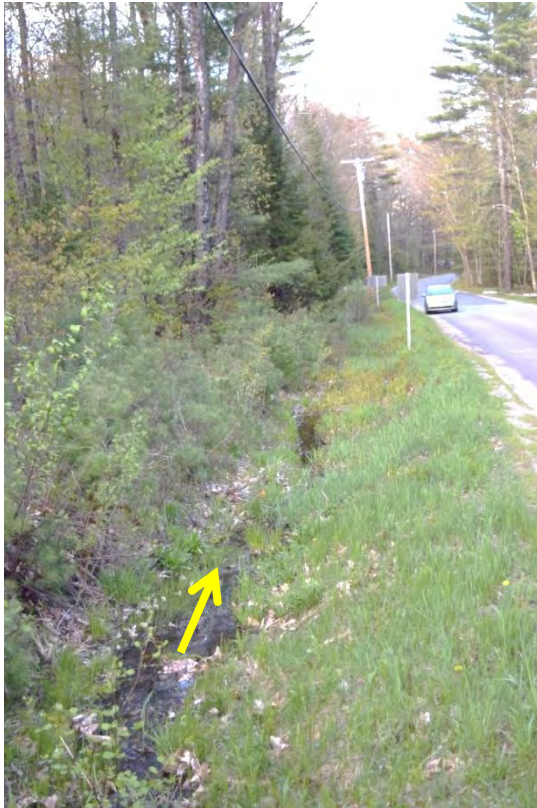
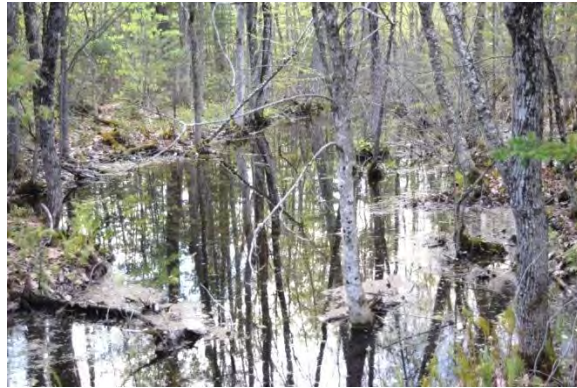
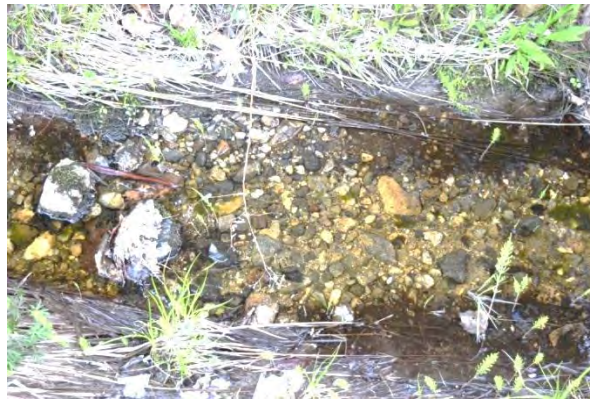
## Case Study 15 – Roadside Drainage #4

| Criteria | Evidence |
|---|---|
| Channel | ✓ Channel with defined banks alongside of road (A) |
| Conclusion | ✓ Despite being a straight channel alongside a road, this is a NRPA stream. The stream was altered in the past to run parallel to the road. It is connected to an upstream waterbody and it returns to a natural channel downstream. It has a defined channel and meets 2 of the 5 other criteria. |

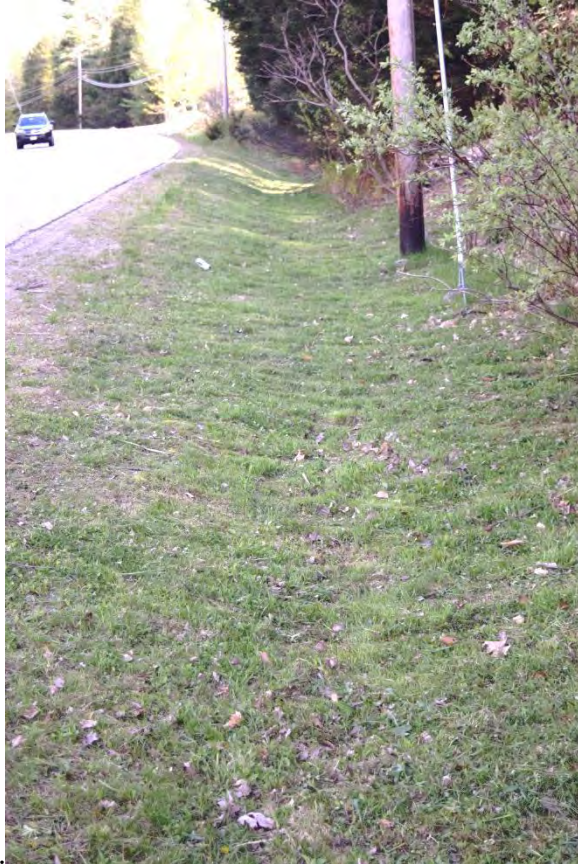
## Case Study 16 – Grassy Swale

| Criteria | Evidence |
|---|---|
| Channel | ✗ No channel with defined banks |
| A. Mineral channel bed | ✗ No exposed minerals caused by flowing water |

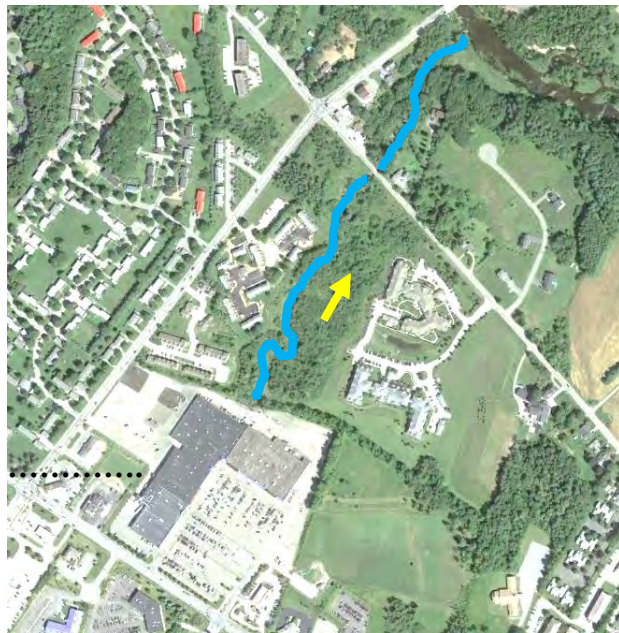
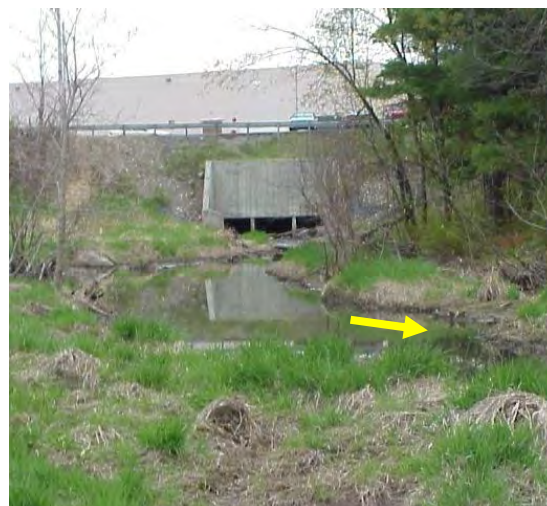
## Case Study 17 – Channel originating from a culvert #1

| Criteria | Evidence | |
|---|---|---|
| Channel | ✓ | Channel with defined banks (A) that originates from a culvert (B) |
| Conclusion | ✓ | This is a NRPA stream. It has a channel with defined banks and 4 of 5 of the other criteria. |

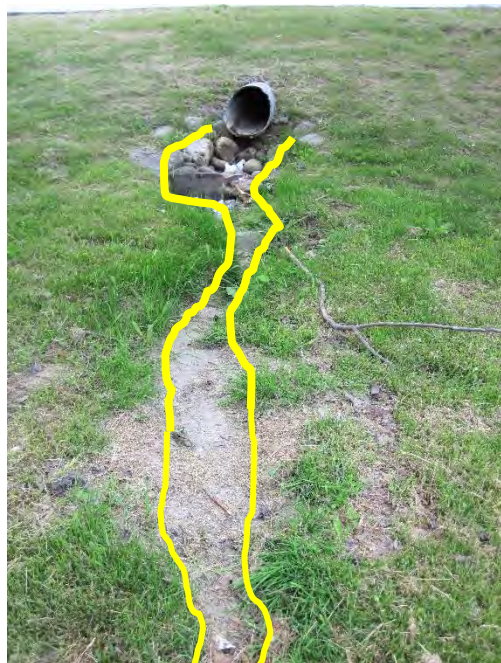
## Case Study 18 – Channel originating from a culvert #2

| Criteria | Evidence | |
|---|---|---|
| Channel | ✓ | Short channel with defined banks that originates from a culvert but dissipates into uplands |
| A. Mineral channel bed | ✓ | Exposed minerals caused by flowing water |

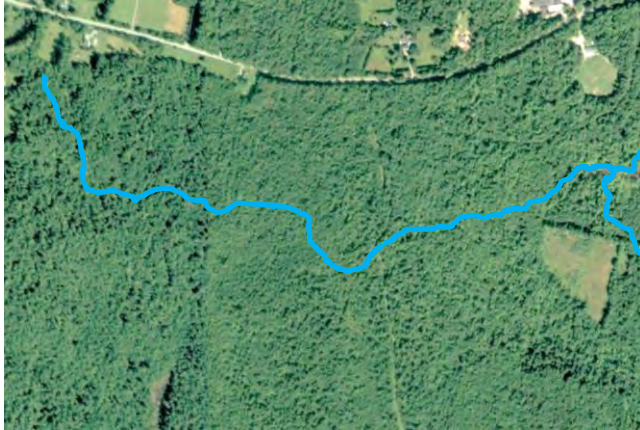
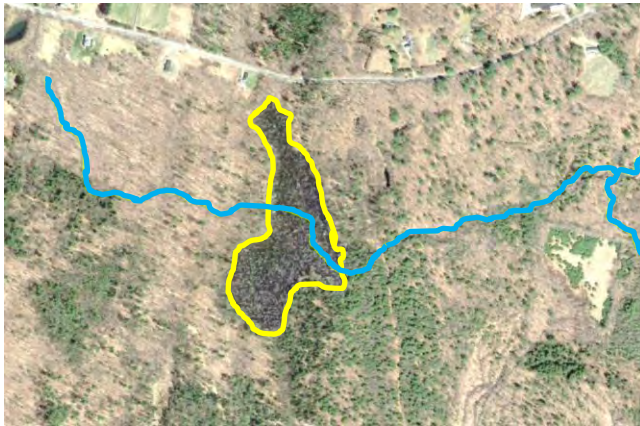
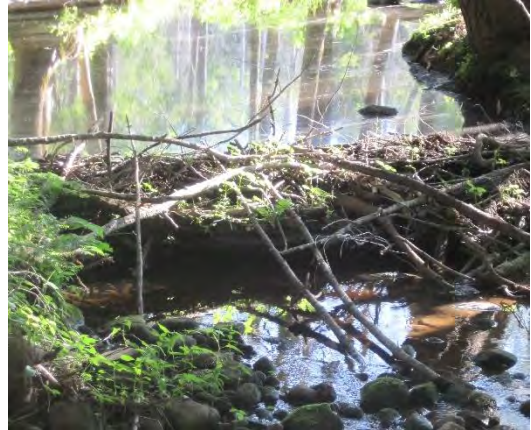
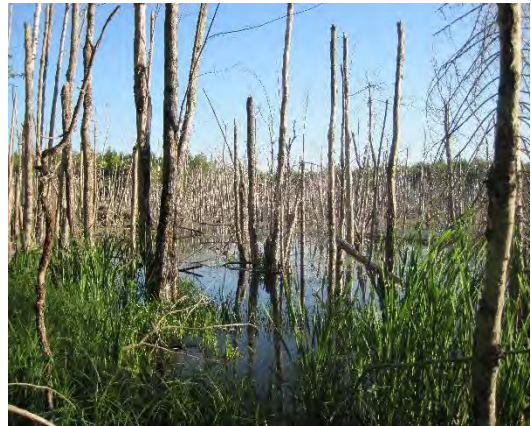
## Case Study 19 – Impounded stream #1

Blue lines show the stream channel and yellow line shows the outline of the beaver pond

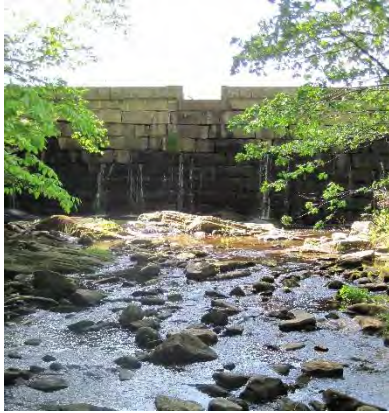
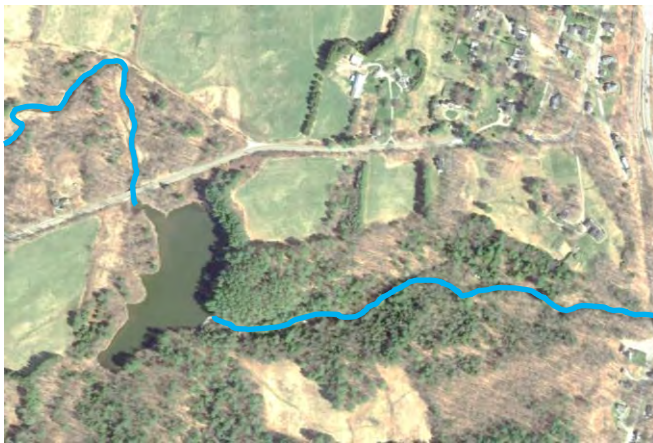
## Case Study 20 – Impounded stream #2

| Criteria | Evidence | |
|---|---|---|
| Channel | ✓ | The inlet and outlet streams have channels with defined banks |

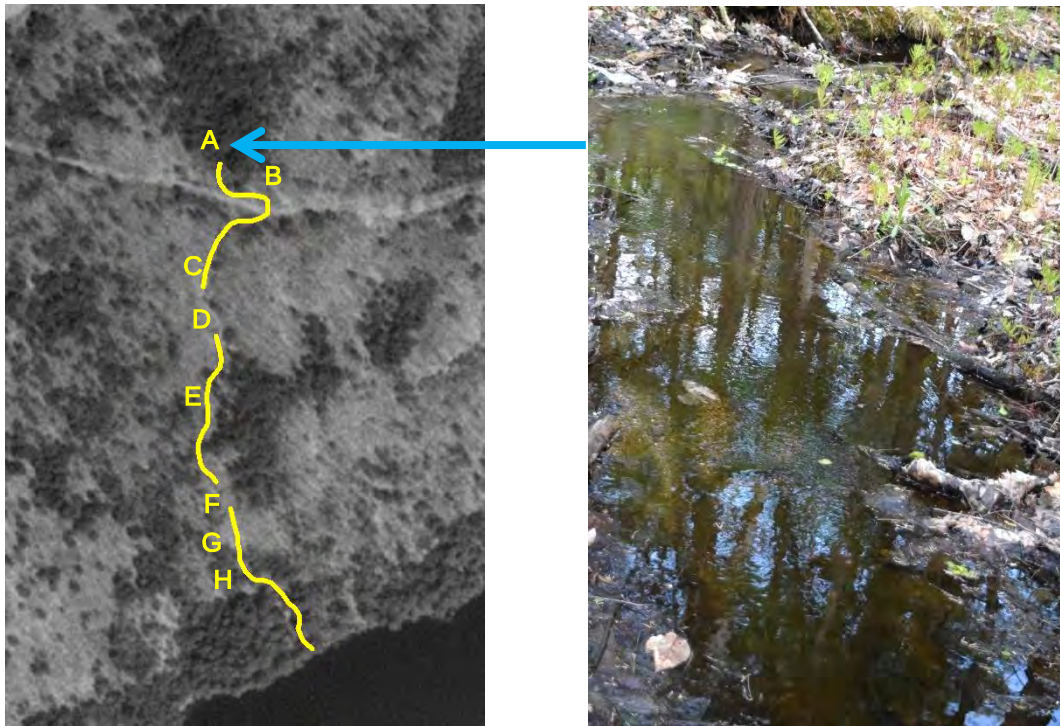
A. Origin of the stream

*Yellow line on map shows NRPA stream segments*

| Criteria | Evidence | |
|---|---|---|
| Channel | × | No channel |

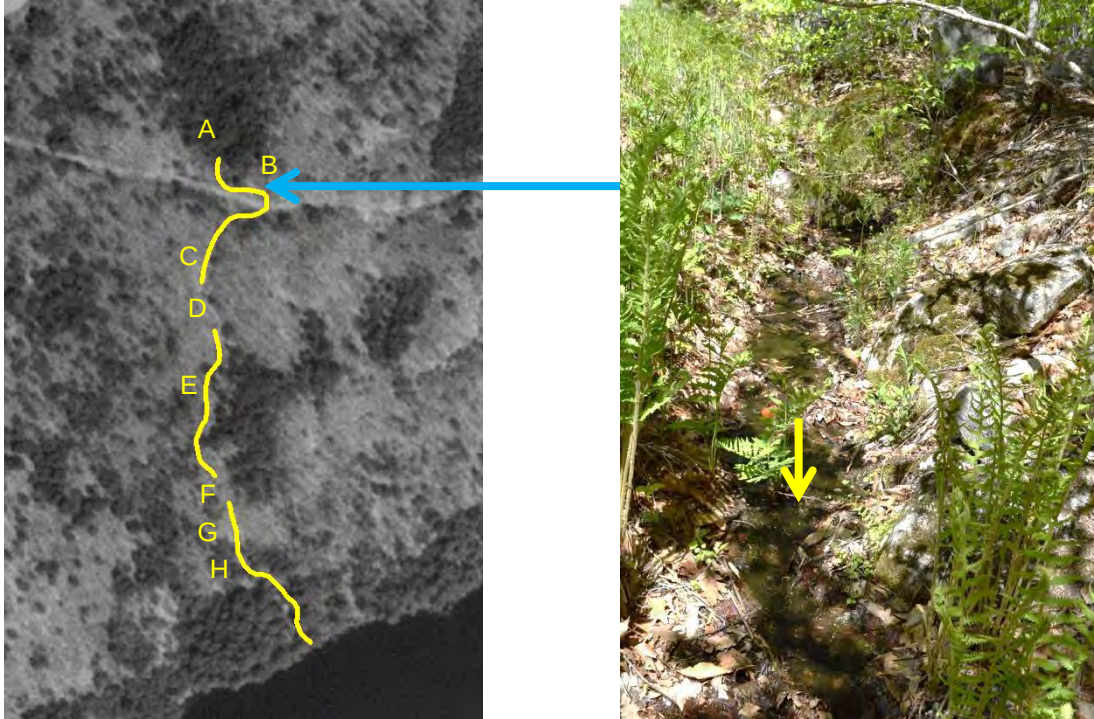
B. Segment of NRPA stream diverted into roadside drainage

| Criteria | Evidence |
|---|---|
| Channel | ✓ Within a roadside drainage, there is a narrow meandering channel (3-5" wide) |

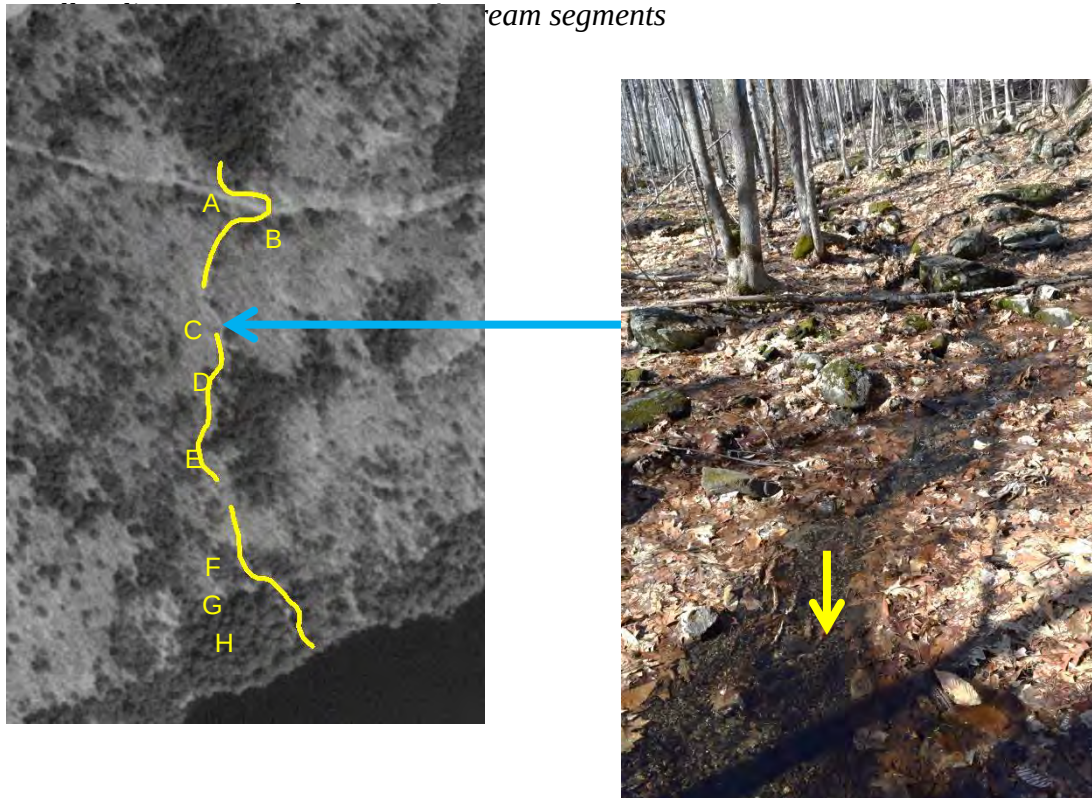
C. NRPA stream segment

| Criteria | Evidence | |
|---|---|---|
| Channel | ✓ | Channel with defined banks |

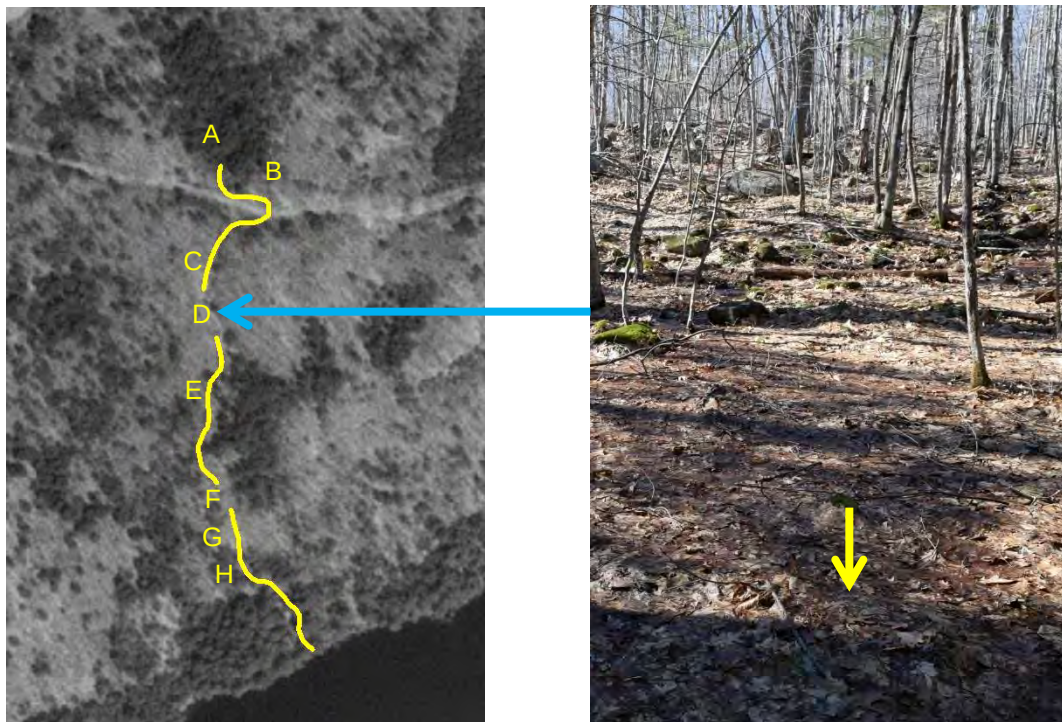
D. Segment in flat area without a defined channel

| Criteria | Evidence | |
|---|---|---|
| Channel | × | The stream enters a flat area, the water spreads out, and there no longer is a channel with defined banks |
| A. Mineral channel bed | × | There is no exposed mineral substrate caused by water movement |

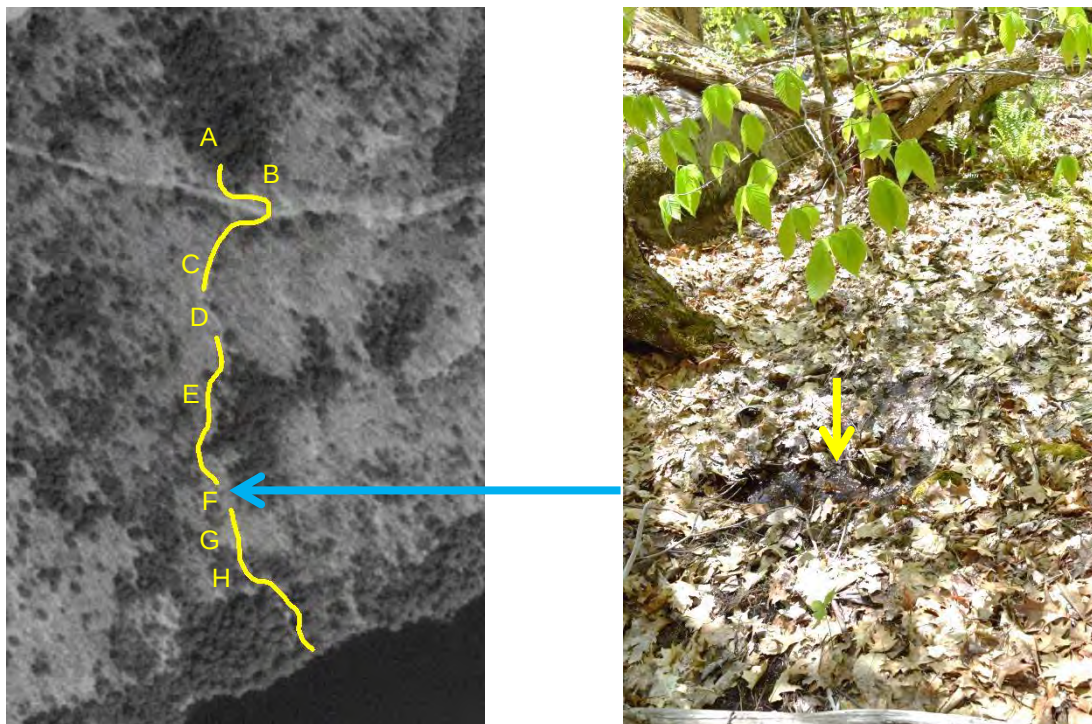
| Criteria | Evidence | |
|---|---|---|
| Channel | × | The water flows underground in this segment |

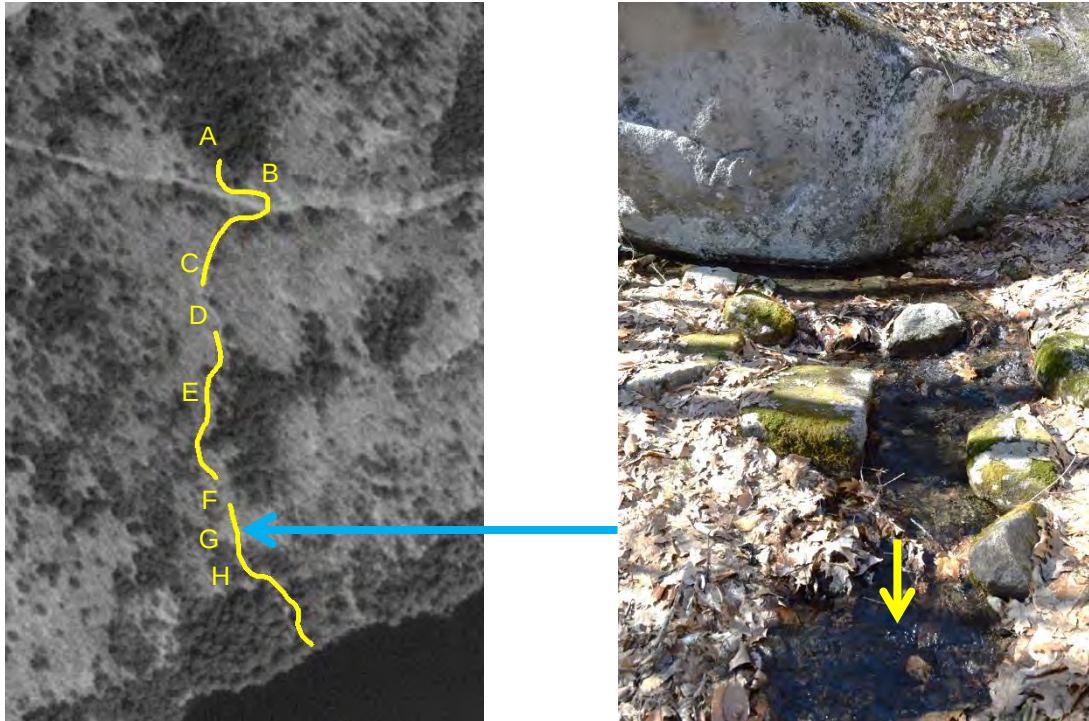
| Criteria | Evidence |
|---|---|
| Channel | ✓ The water returns to the surface next to the boulder and forms a channel with defined banks |
