# Natural Resource Protection Act (NRPA) Identification Guide for Rivers, Streams, and Brooks

Danielson, T. J. 2018. *Natural Resource Protection Act (NRPA) Streams, Rivers, and Brooks*. Maine Department of Environmental Protection, Augusta, ME.

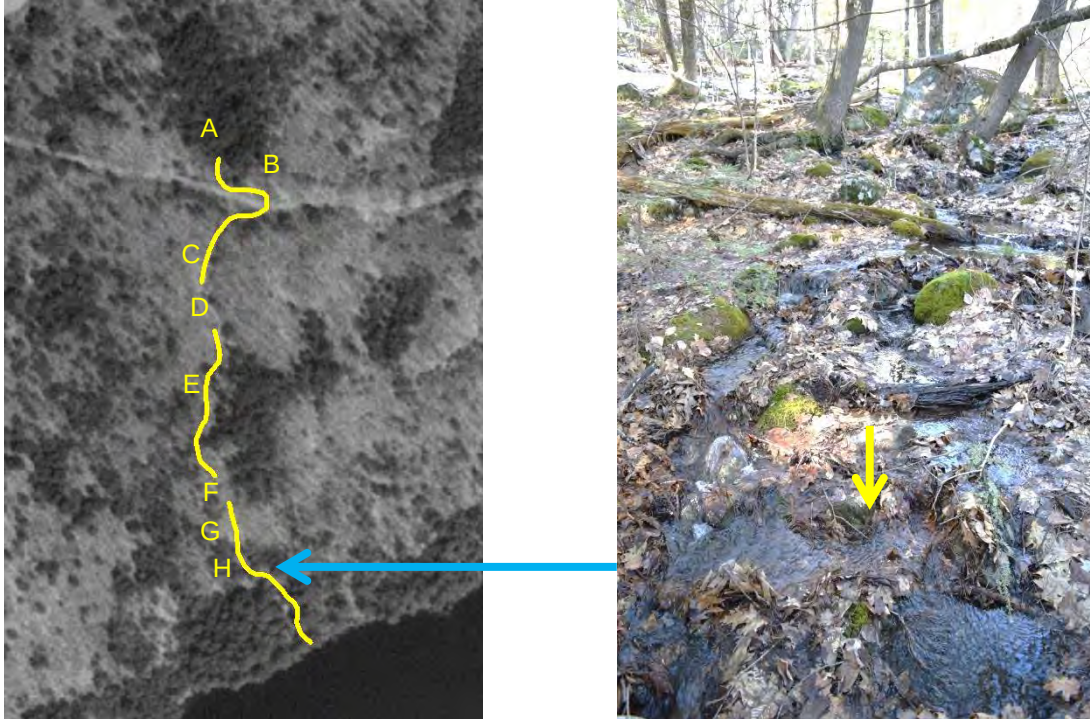
| Criteria | Evidence | |
|---|---|---|
| Channel | ✓ | This channel is braided because of large rocks and steeper slope |

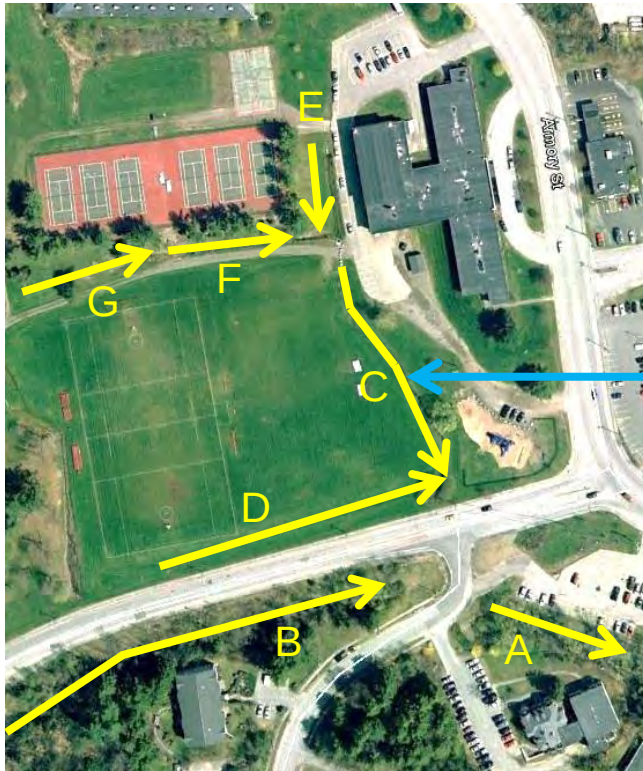
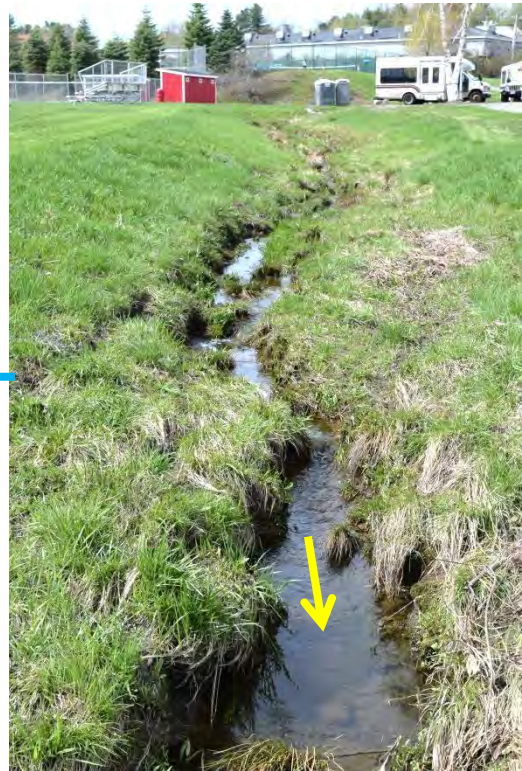
## Segment C: Modified stream segment

| Criteria | Evidence | |
|---|---|---|
| Channel | ✓ | Channel with defined banks (some stream bank erosion and slumping) |

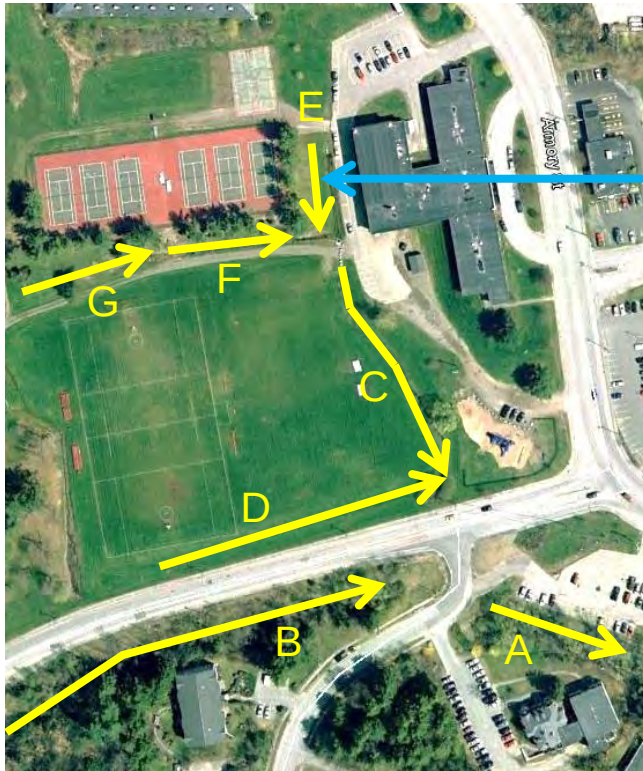
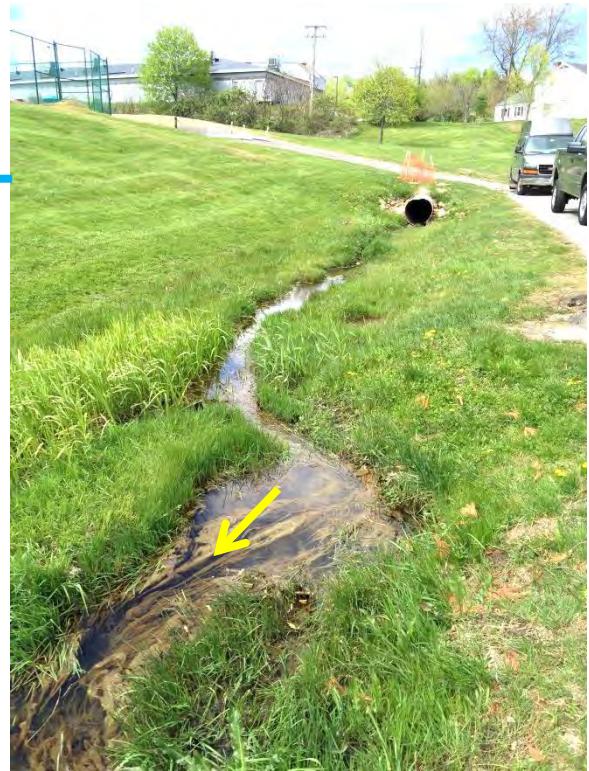
## Segment E: Modified stream segment that originates form a pipe

| Criteria | Evidence |
|---|---|
| Channel | ✓ It has a channel with defined banks, it has enough flowing water to maintain a channel away from the culvert opening, and it connects to a downstream waterbody |

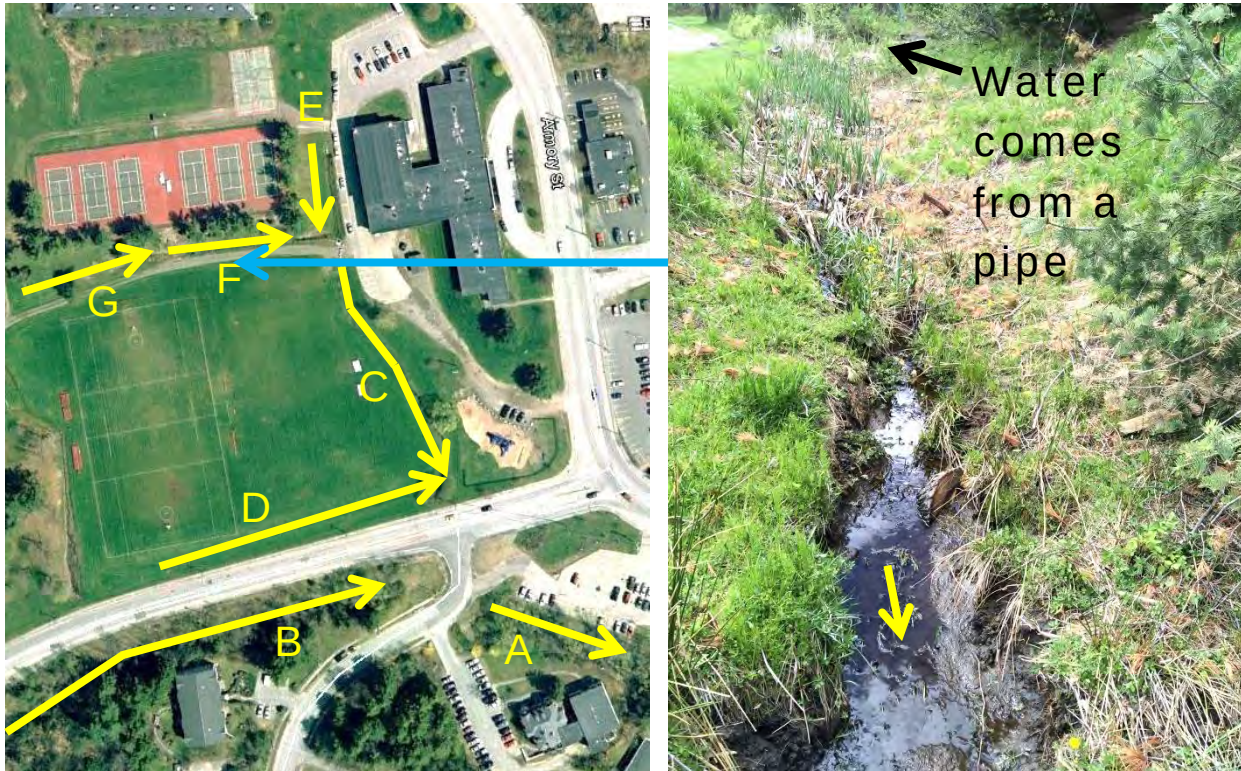
## Segment F: Modified stream segment that originates form a pipe

| Criteria | Evidence |
|---|---|
| Channel | ✓ There is a straight drainage way containing a channel with defined banks. Flowing water originates from a pipe that drains groundwater from underneath the tennis courts. There is enough flowing water to maintain a channel away from the culvert opening and it connects to Kennedy Brook. |
| C. Continuous flow for 6 months | -- Not sure but it remains wet for a long period of time and receives a lot of groundwater from the pipe that drains underneath the tennis courts. Groundwater sometimes comes to the surface of the tennis courts through cracks in the playing surface. |

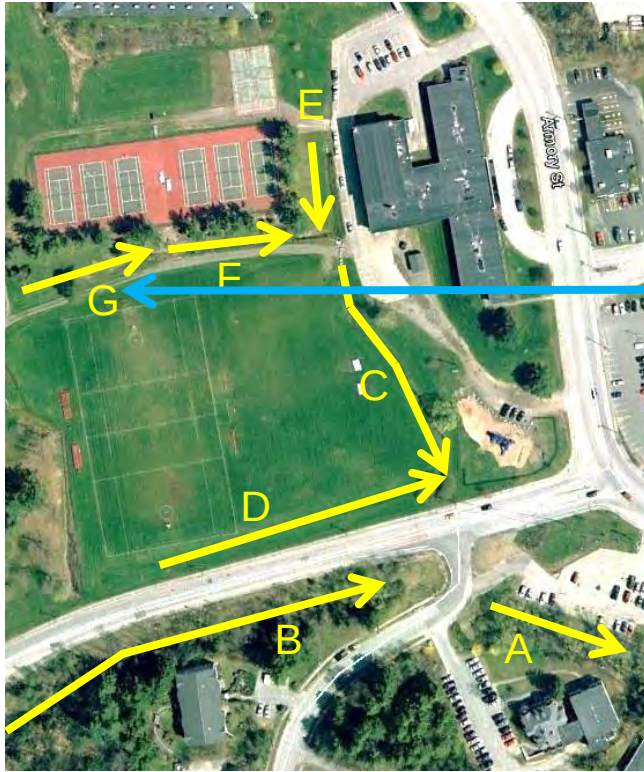
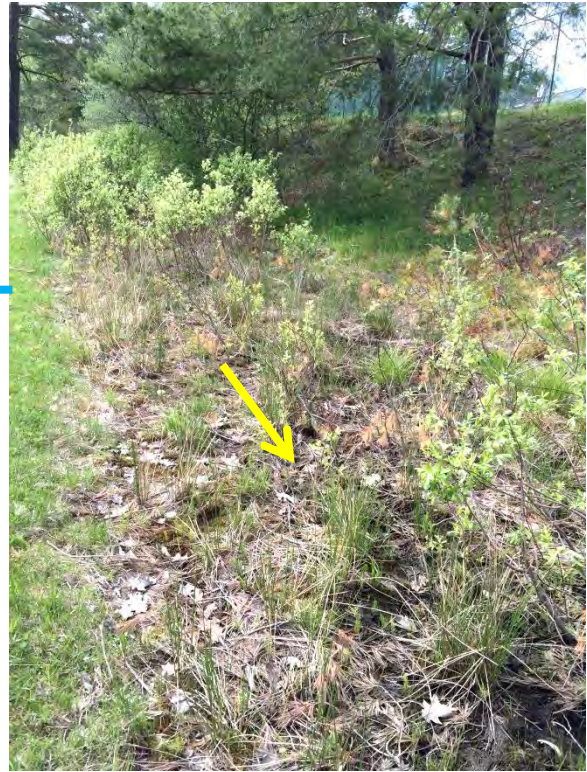
## Segment G: Linear wetland

| Criteria | Evidence |
|---|---|
| Channel | ✗ This is a straight drainage feature, but it does not have a channel with banks. |
| A. Mineral channel bed | ✗ There is no exposed mineral substrate caused by water movement |
