# Maine Statewide Bacteria TMDL:2013 Freshwater Addendum

## Appendix A: Duck Brook Bacteria Sampling Project Reports

Report #: DEPLW-1254

*2012 Data Report  
Duck Brook - Arundel, Maine*

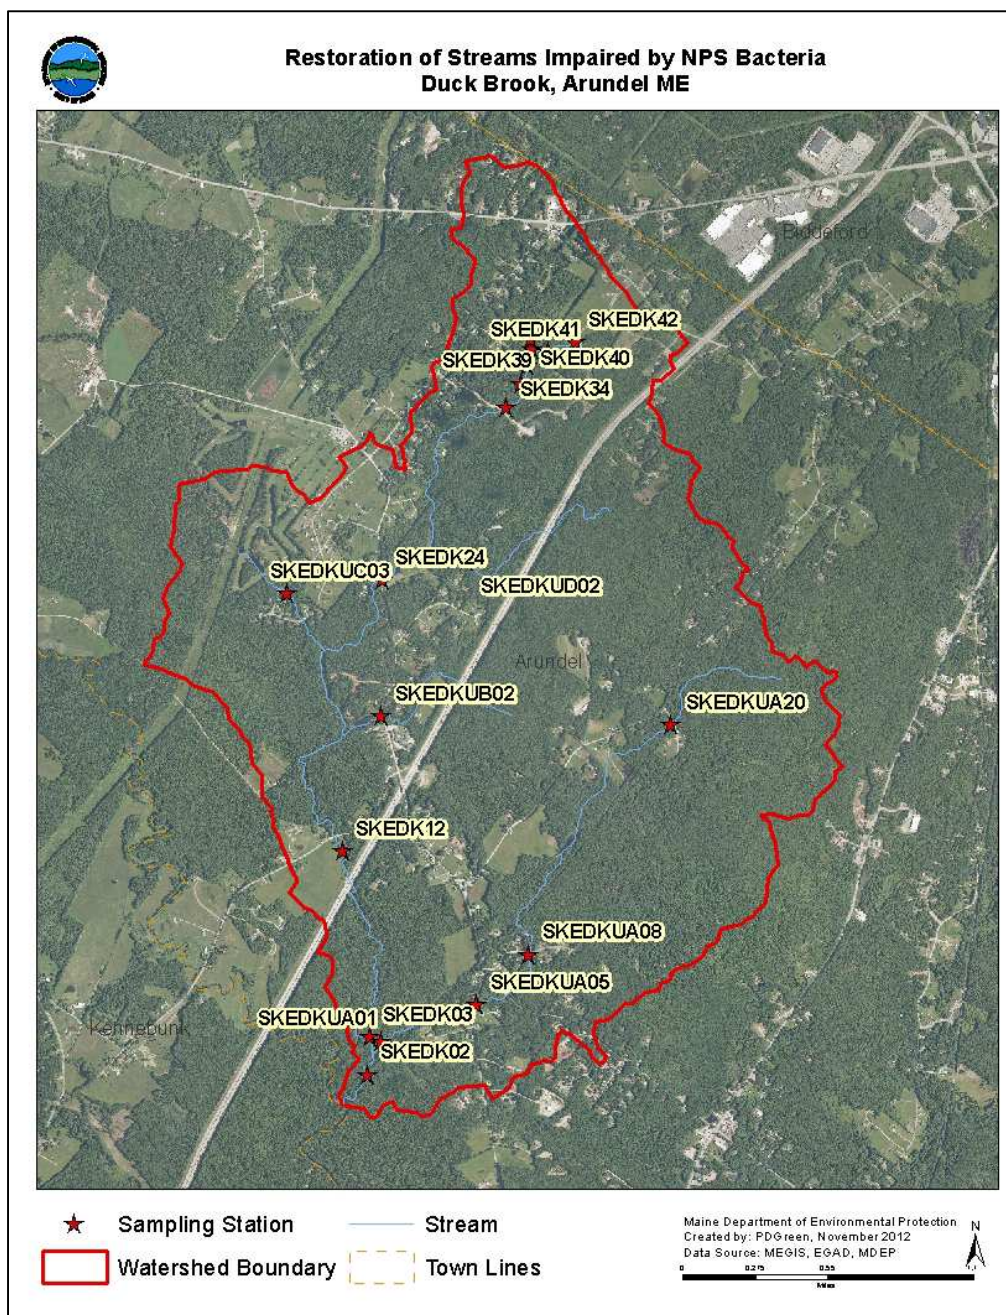
**Figure 1.** Duck Brook flows through a mixed landscape.

Duck Brook is a Class B stream situated in the town of Arundel in York County, Maine (Figure 1). The lower main stem flows for 0.31 miles before it empties into the Kennebunk River. The Duck Brook watershed drains approximately 6.64 square miles of the greater Piscataqua-Presumpscot-Saco watershed. In addition to the main stem, five tributaries are included in this discussion.

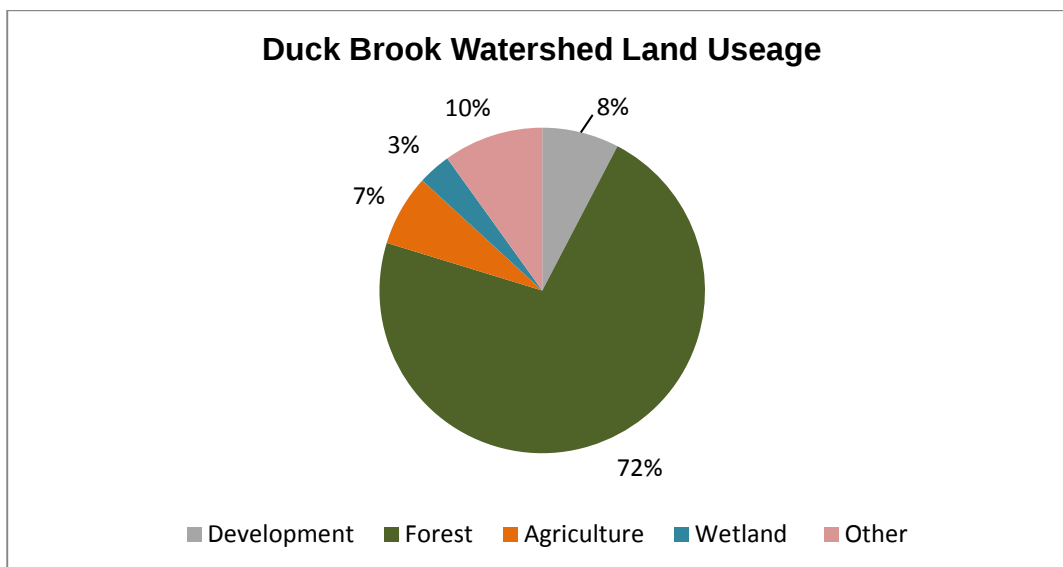
**Figure 2.** Forest covers the majority of the Duck Brook watershed.

The Duck Brook watershed is primarily defined by natural drainage divides resulting from topography and elevation contours. Watershed drainage is also subject to development, land use, and impervious surface. The Duck Brook watershed has 6.0% impervious surface nested within a land cover mosaic of: 7.6% development including developed open spaces; 72.1% coniferous, deciduous, or mixed forest vegetation; 7.1% agriculture characterized as pastures, crops, or blueberry fields; 3.3% wetland cover; and 9.9% classified as other with herbaceous plants and shrubs (Figure 2).

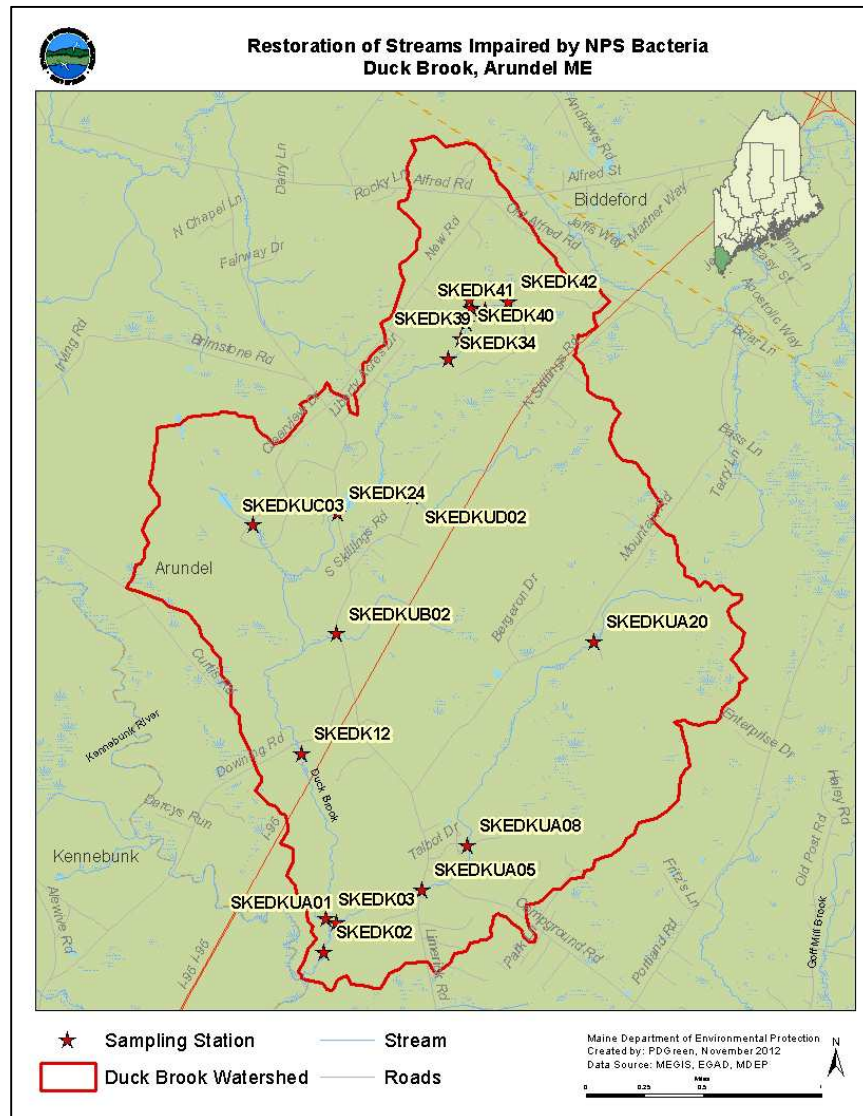
**Figure 3.** Extensive sampling of the Duck Brook watershed involved two sampling teams in 2012.

Sampling stations were established to achieve representative sampling of the watershed (Figure 3) The downstream location (SKEDK02) on the Eastern Trail was close to the downstream site

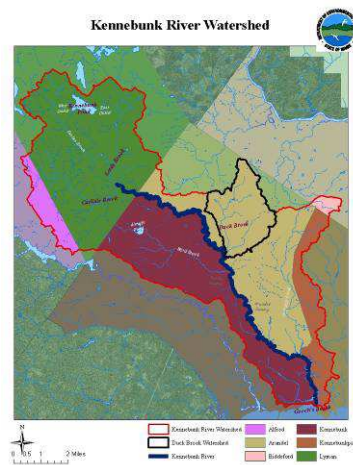
**Figure 1.1: A map of the Kennebunk River watershed and surrounding towns.**

The Kennebunk River is a Class B river located in York County and it has a length of 17.6 miles and a watershed area of 38 square miles (see Figure 1.1). It originates at the confluence of Lords Brook and Carlisle Brook in Lyman and flows southwest through the towns of Arundel, Kennebunk and Kennebunkport before emptying into the Gooch's Beach. Located in the Piscataqua River Watershed, the Kennebunk River is listed for "bacteria-only" impairment as specified in Maine's 2004 305(b) report, and remains on the updated 2010 list.<sup>3</sup> The bacterial contamination is listed as nonpoint source pollution and is widespread throughout the watershed<sup>4</sup>.

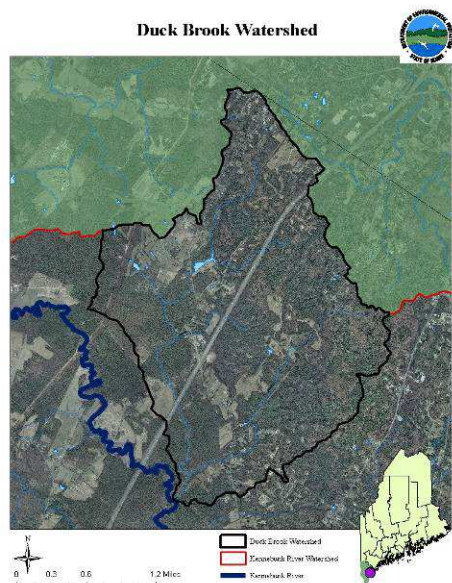
**Figure 1.2: An aerial photo map of Duck Brook watershed boundary.**

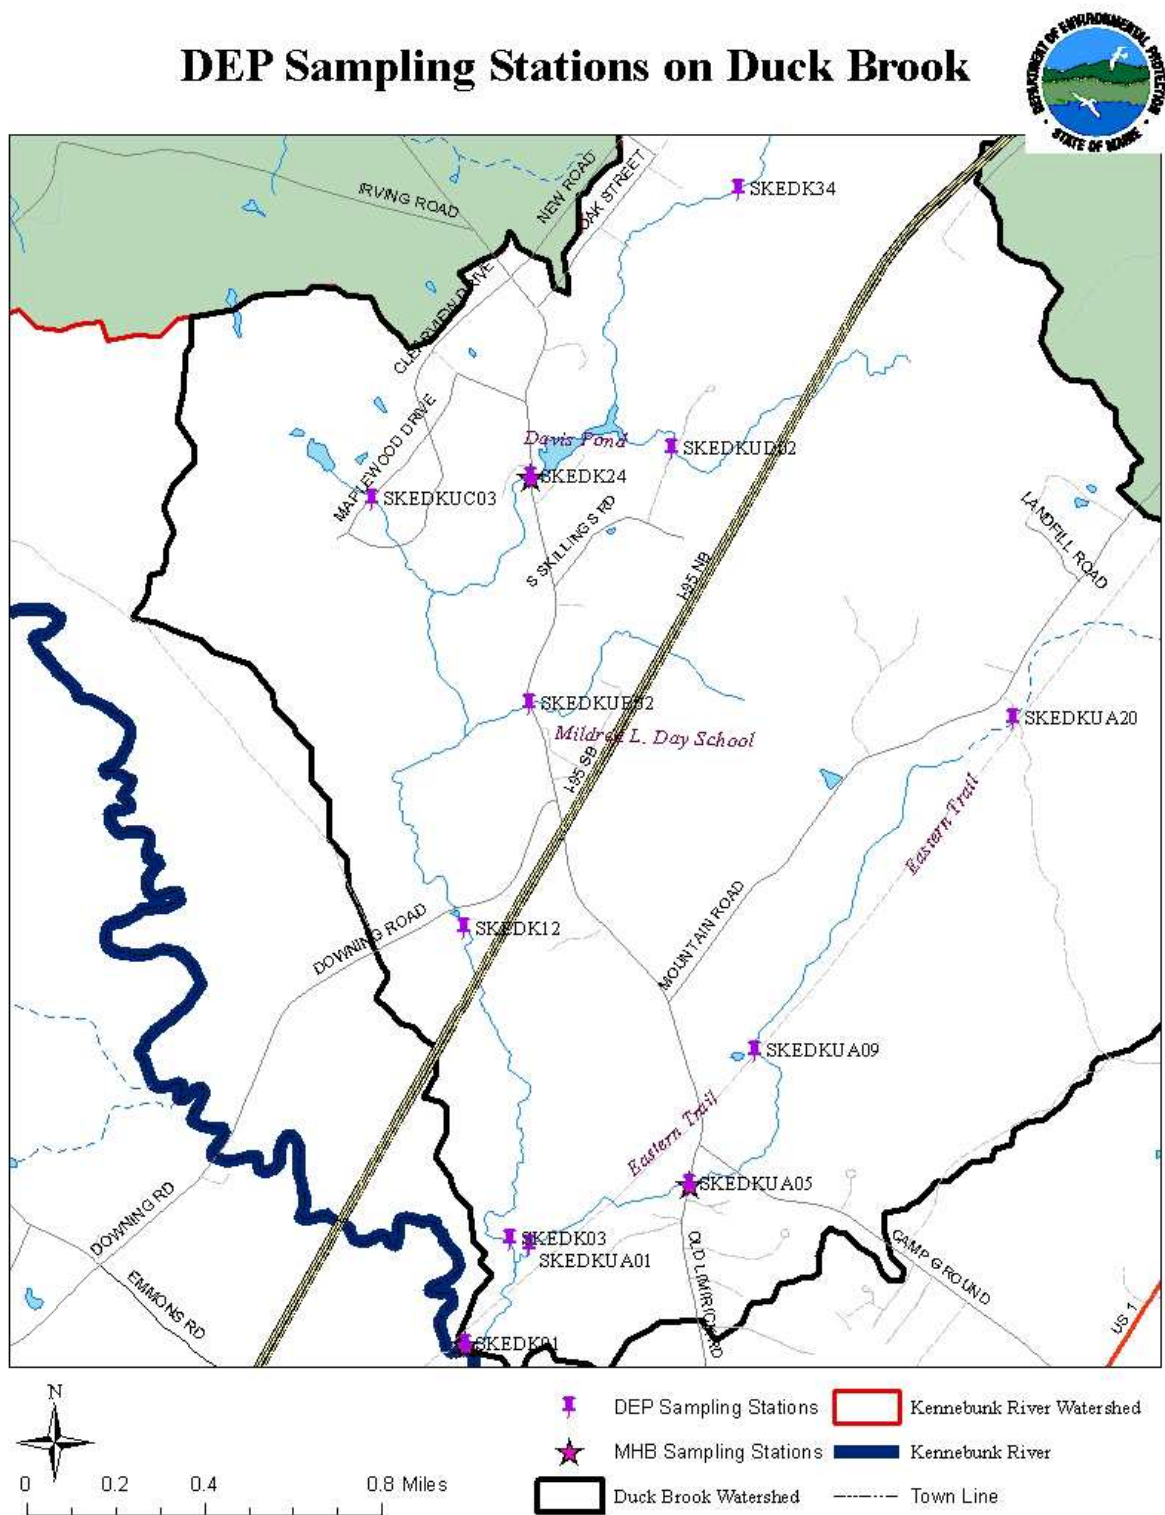
Figure 1.3: Maine Department of Environmental Protection sampling stations on Duck Brook.

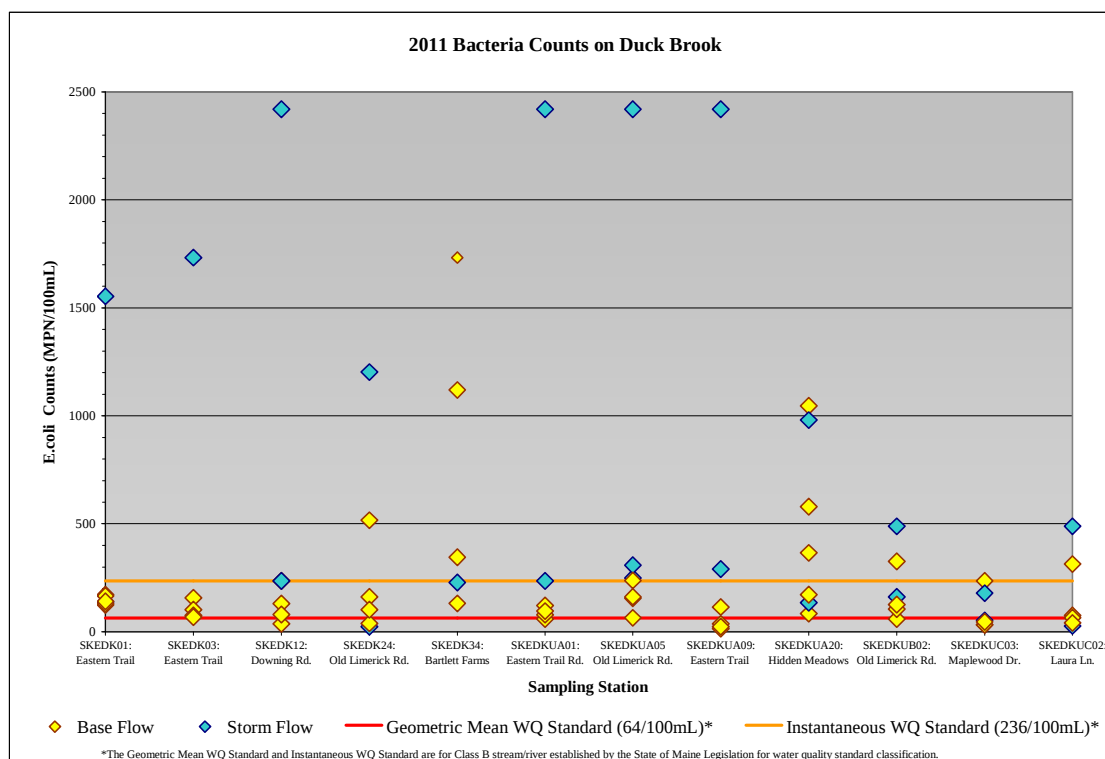
**Figure 1.4: Below is a graph summary of the 2011 bacteria counts on Duck Brook. The original sampling station Eastern Trail (SKEDK01) is in the bottom left hand corner of the graph.**

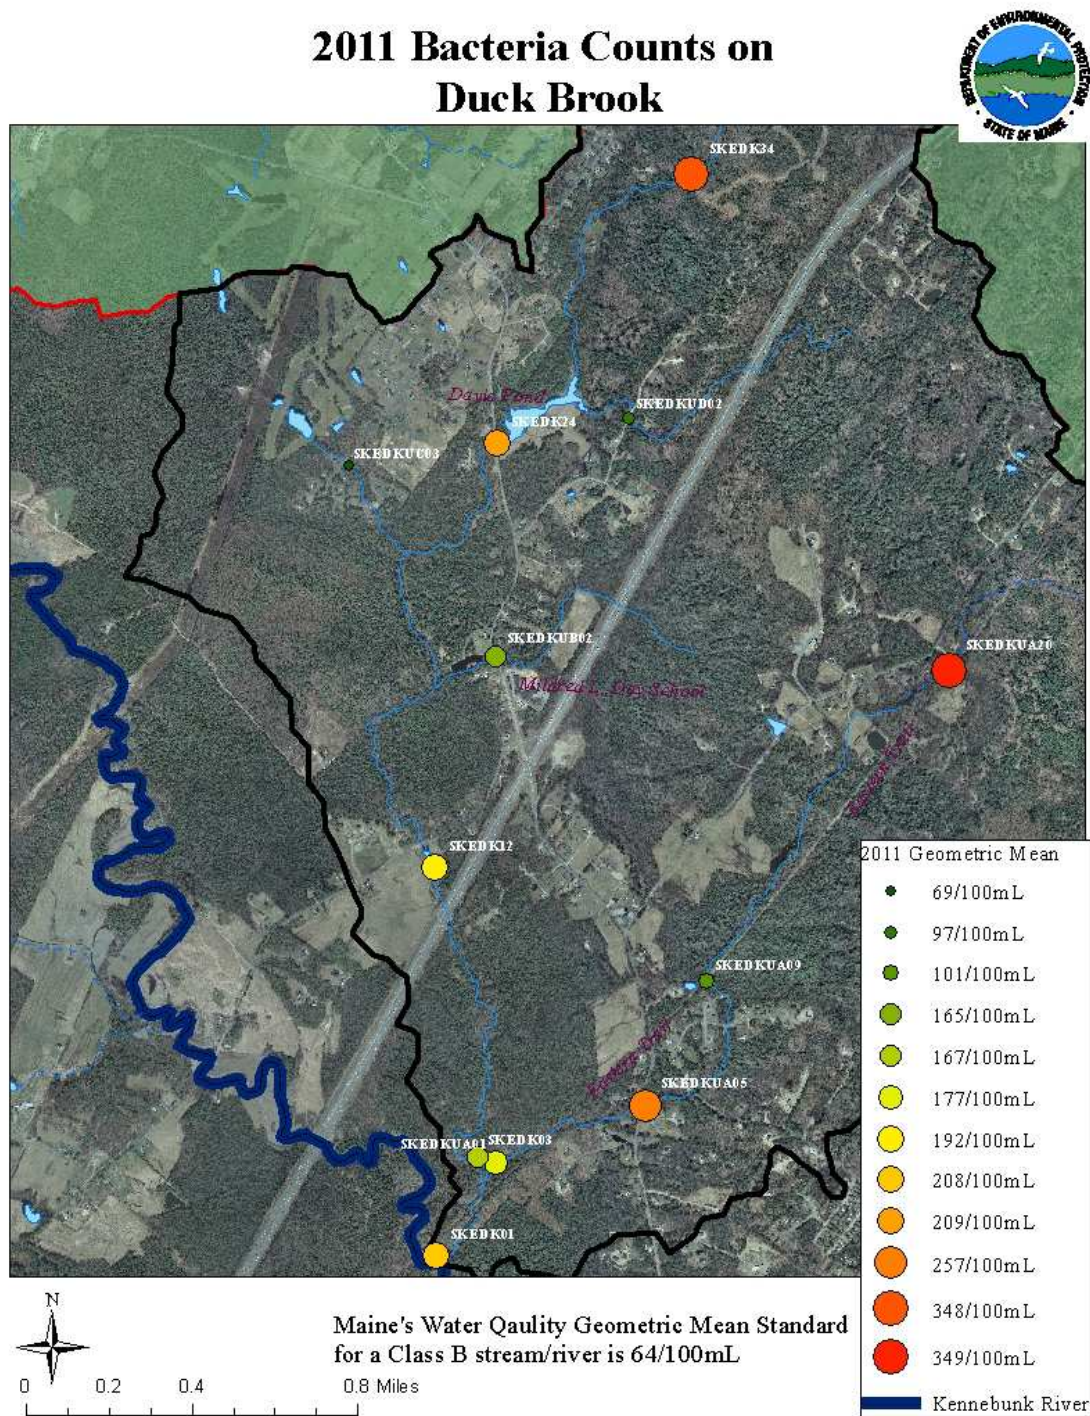
Figure 1.5: A visual representation of the 2011 bacteria counts on Duck Brook.<sup>5</sup>

<sup>5</sup> Please note the legend represents the geometric mean at each sampling station in order from non-attainment to attainment for a Class B stream/river.

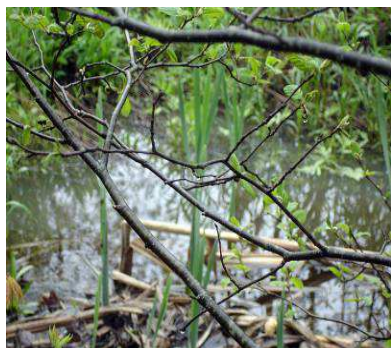
**Figure 1.6. A picture of water with the “grayish water” appearance near Limerick Rd (SKEDKUA05) sampling station.**

The portion closest to the mouth of Duck Brook is Tributary A. While sampling during both storms events, water with a “grayish water” appearance was observed near the Limerick Rd (SKEDKUA05) sampling station (see Figure 1.7). There are a few houses to the right (while looking upstream from the road) of the station on Skyview Acres Dr., as well as the small subdivision just above the station on Talbot Dr. Both are candidates for sanitary surveys. The bacteria contamination in this portion of the watershed is confined to this particular stream segment; limiting the scope of work. The Eastern Trail (SKEDKUA09) sampling station is directly above the subdivision and attains water quality standards. However, farther up on Tributary A, malfunctioning systems were detected at Hidden Meadows. There are few houses on Hidden Meadows that are above the Hidden Meadows (SKEDKUA20) sampling station and after that it is a forested area. Sanitary surveys and additional investigation will be needed in the area.
